General Information

Make	Toyota	Model	Lite Ace
YOM	2025	Odo Meter Reading	13,386
Registration No.	NJA7639	Chassis No.	MHKB3FE10RK005378
CC	1.5	Transmission	M/T
Fuel Type	Diesel	Type of Body	Utility Cargo
Colour	White

Body / Panel Condition

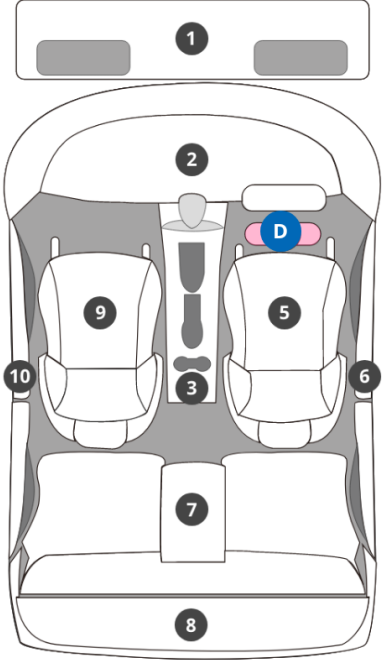
Interior Evaluation : B	Exterior Evaluation : D

<p>a : Cut, Fray d : Loose, Deformed k : Animal Hair s : Smell t : Cigarette Burns x : Defective y : Stain</p>

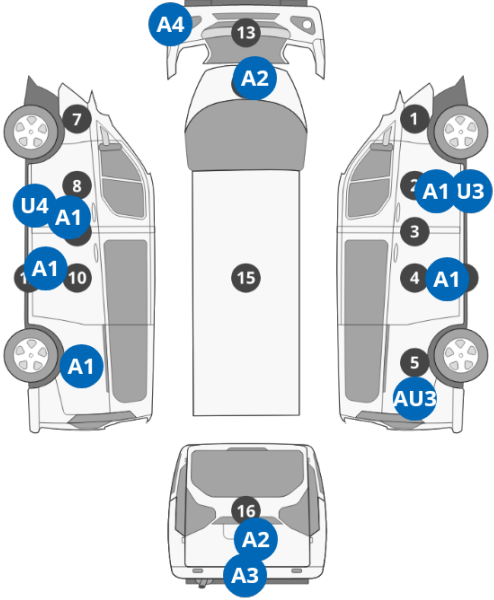
<p>A : Scratch AU : Scratch & Dent B : Modified C : Corrosion G : Stone chip P : Faded S : Rust SC : Rust & Corrosion U : Dent X : Defective Y : Crack, Gap</p>
Remarks Carpet - Repair Mark - Yes	Remarks (R) Rear Fender, Molding - Scratch & Dent - Medium / Rear Bumper, Lamps, Panels - Scratch - Medium / Front Bumper, Grille, Lamps - Scratch - Large / (L) Step, In-panel, Side Spoiler - Dent - Large / (R) Step, In-panel, Side Spoiler - Dent - Medium / Bonnet, Headlight - Scratch - Small / (R) Front Door, Molding - Scratch - Minimal / (R) Rear Door, Molding - Scratch - Minimal / Trunk Hood, Rear Gate - Scratch - Small / (L) Rear Fender, Molding - Scratch - Minimal / (L) Rear Door, Molding - Scratch - Minimal / (L) Front Door, Molding - Scratch - Minimal
