General Information

Make	Toyota	Model	Vios
YOM	2023	Odo Meter Reading	16,973
Registration No.	EAJ5419-1	Chassis No.	PA1B18F36P422871
CC	1.3	Transmission	M/T
Fuel Type	Gas	Type of Body	Sedan
Colour	Black

Body / Panel Condition

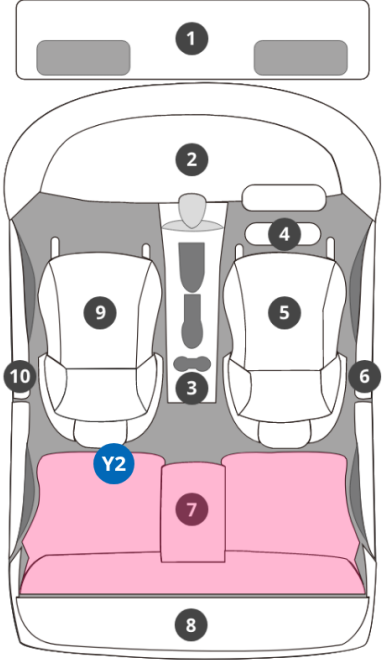
<p>a : Cut, Fray d : Loose, Deformed k : Animal Hair s : Smell t : Cigarette Burns x : Defective y : Stain</p>

<p>A : Scratch AU : Scratch & Dent B : Modified C : Corrosion G : Stone chip P : Faded S : Rust SC : Rust & Corrosion U : Dent X : Defective Y : Crack, Gap</p>
Remarks Rear Seat - Grime - Small	Remarks Bonnet - Repair Traces - Yes / (R) Front Fender, Molding - Scratch - Minimal / (R) Front Door, Molding - Scratch - Minimal / (R) Rear Door, Molding - Scratch - Small / (R) Step, In-panel, Side Spoiler - Scratch - Minimal / Rear Bumper, Lamps, Panels - Scratch - Medium / Trunk Hood, Rear Gate - Scratch - Minimal / Roof - Scratch - Small / (L) Rear Door, Molding - Scratch - Minimal / (L) Front Door, Molding - Scratch - Minimal / (L) Front Fender, Molding - Scratch - Minimal / Bonnet, Headlight - Scratch & Dent - Medium / Front Bumper, Grille, Lamps - Scratch - Small

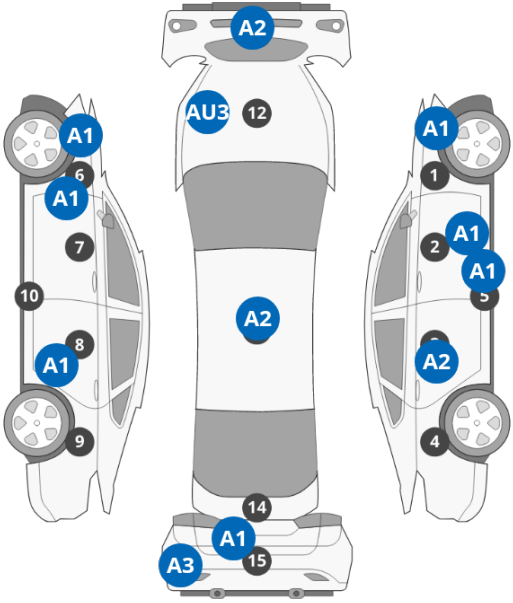
Inspector Notes
With Lto plate, with spare tire and jack, no warranty booklet, no tools, 1key, scratches on headlights and taillights
