General Information

Make	Mitsubishi	Model	Mirage
YOM	2017	Odo Meter Reading	54,478
Registration No.	NCA6241	Chassis No.	PAEA03TJHHA000557
CC	1.2	Transmission	A/T
Fuel Type	Gas	Type of Body	Hatchback
Colour	Red

Body / Panel Condition

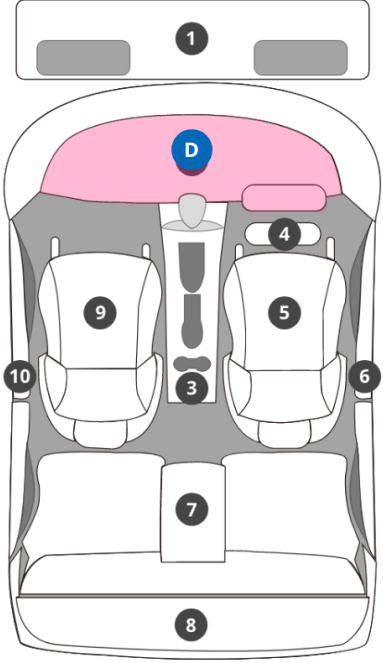
Interior Evaluation : A	Exterior Evaluation : E

<p>a : Cut, Fray d : Loose, Deformed k : Animal Hair s : Smell t : Cigarette Burns x : Defective y : Stain</p>

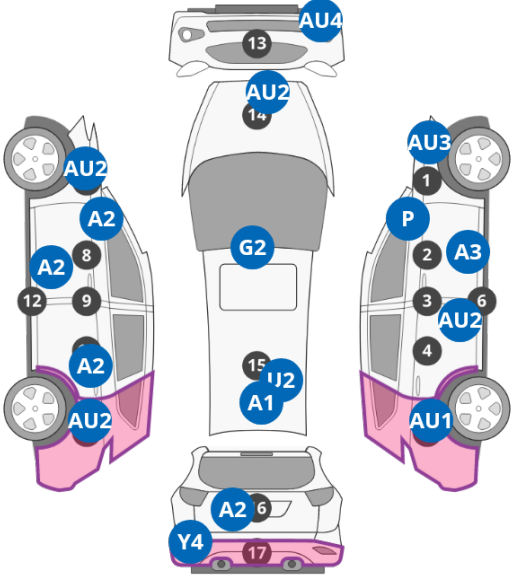
<p>A : Scratch AU : Scratch & Dent B : Modified C : Corrosion G : Stone chip P : Faded S : Rust SC : Rust & Corrosion U : Dent X : Defective Y : Crack, Gap</p>
Remarks Dashboard - Traces of Adhesive Tape - Yes	Remarks (R) Front Fender, Molding - Scratch & Dent - Medium / (R) Mirror - Faded(Color, Gloss) - Yes / (R) Front Door, Molding - Scratch - Medium / (R) Rear Door, Molding - Scratch & Dent - Small / (R) Rear Fender, Molding - Scratch & Dent - Minimal / (R) Rear Fender, Molding - Repair mark - Yes / Rear Bumper, Lamps, Panels - Crack, Gap - Large / Rear Bumper, Lamps, Panels - Repair mark - Yes / Trunk Hood, Rear Gate - Scratch - Small / (L) Rear Fender, Molding - Repair mark - Yes / (L) Rear Fender, Molding - Scratch & Dent - Small / (L) Rear Door, Molding - Scratch - Small / (L) Front Door, Molding - Scratch - Small / (L) Mirror - Scratch - Small / (L) Front Fender, Molding - Scratch & Dent - Small / Front Bumper, Grille, Lamps - Scratch & Dent - Large / Front Windshield - Scratch, Stone chip - Small / Bonnet, Headlight - Scratch & Dent - Small / Roof - Dent - Small / Roof Spoiler, Molding - Scratch - Minimal

Inspector Notes
With Lto plate, with warranty booklet, 2keys, with spare tire, no jack and tools, scratches on headlights and taillights
