General Information

Make	Toyota	Model	Vios
YOM	2024	Odo Meter Reading	40,619
Registration No.	DBF8510	Chassis No.	PA1B18F31R4250069
CC	1.3	Transmission	CVT
Fuel Type	Gas	Type of Body	Sedan
Colour	Red Mica Metallic

Body / Panel Condition

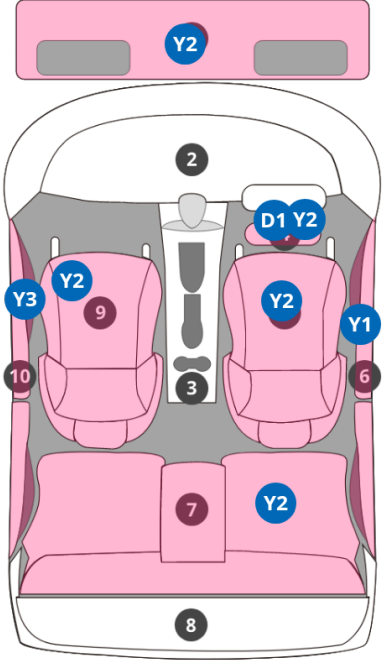
Interior Evaluation : B	Exterior Evaluation : E

<p>a : Cut, Fray d : Loose, Deformed k : Animal Hair s : Smell t : Cigarette Burns x : Defective y : Stain</p>

<p>A : Scratch AU : Scratch & Dent B : Modified C : Corrosion G : Stone chip P : Faded S : Rust SC : Rust & Corrosion U : Dent X : Defective Y : Crack, Gap</p>
<p>Remarks (L) Front Trim - Grime - Medium / Rear Seat - Grime - Small / (L) Front Seat - Grime - Small / (R) Front Seat - Grime - Small / Ceiling - Grime - Small / Carpet - Worked - Minimal / (R) Front Floor Mat - Grime - Small / (R) Front Trim - Grime - Minimal</p>	<p>Remarks (R) Front Fender, Molding - Scratch & Dent - Medium / (R) Front Door, Molding - Scratch - Large / (R) Rear Door, Molding - Scratch - Small / (R) Step, In-panel, Side Spoiler - Scratch & Dent - Small / (R) Rear Fender, Molding - Scratch - Medium / Trunk Hood, Rear Gate - Scratch & Dent - Small / Rear Bumper, Lamps, Panels - Scratch & Dent - Small / (L) Rear Fender, Molding - Scratch - Medium / (L) Rear Door, Molding - Scratch - Small / (L) Front Door, Molding - Scratch - Small / (L) Step, In-panel, Side Spoiler - Scratch - Small / (L) Front Fender, Molding - Scratch - Small / Front Bumper, Grille, Lamps - Scratch & Dent - Medium / Bonnet, Headlight - Scratch - Medium / Roof - Scratch & Dent - Small</p>
