General Information

Make	Toyota	Model	Wigo
YOM	2023	Odo Meter Reading	15,548
Registration No.	DBJ7692	Chassis No.	MHKAA1BC3PJ002303
CC	1.0	Transmission	CVT
Fuel Type	Gas	Type of Body	Hatchback
Colour	Red

Body / Panel Condition

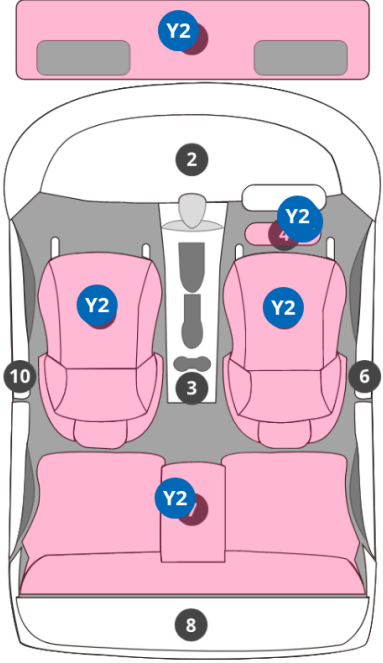
<p>a : Cut, Fray d : Loose, Deformed k : Animal Hair s : Smell t : Cigarette Burns x : Defective y : Stain</p>

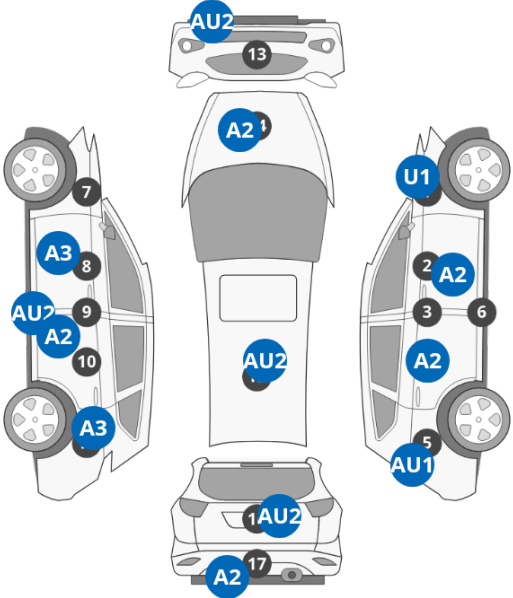
<p>A : Scratch AU : Scratch & Dent B : Modified C : Corrosion G : Stone chip P : Faded S : Rust SC : Rust & Corrosion U : Dent X : Defective Y : Crack, Gap</p>
<p>Remarks (R) Front Floor Mat - Grime - Small / (L) Front Floor Mat - Grime - Small / (L) Front Seat - Grime - Small / (R) Front Seat - Grime - Small / Rear Seat - Grime - Small / Ceiling - Grime - Small</p>	<p>Remarks (L) Front Door - Repair Traces - Yes / (L) Rear Door - Repair Traces - Yes / Bonnet, Headlight - Scratch - Small / (L) Front Door, Molding - Scratch - Medium / (L) Step, In-panel, Side Spoiler - Scratch & Dent - Small / (L) Rear Door, Molding - Scratch - Small / (L) Rear Fender, Molding - Scratch - Medium / Trunk Hood, Rear Gate - Scratch & Dent - Small / Rear Bumper, Lamps, Panels - Scratch - Small / Roof - Scratch & Dent - Small / (R) Rear Fender, Molding - Scratch & Dent - Minimal / (R) Rear Door, Molding - Scratch - Small / (R) Front Door, Molding - Scratch - Small / (R) Front Fender, Molding - Dent - Minimal / Front Bumper, Grille, Lamps - Scratch & Dent - Small</p>
