General Information

Make	Toyota	Model	Vios
YOM	2024	Odo Meter Reading	23,123
Registration No.	DBM2725	Chassis No.	PA1B18F30R4243694
CC	1.3	Transmission	CVT
Fuel Type	Gas	Type of Body	Sedan
Colour	Green

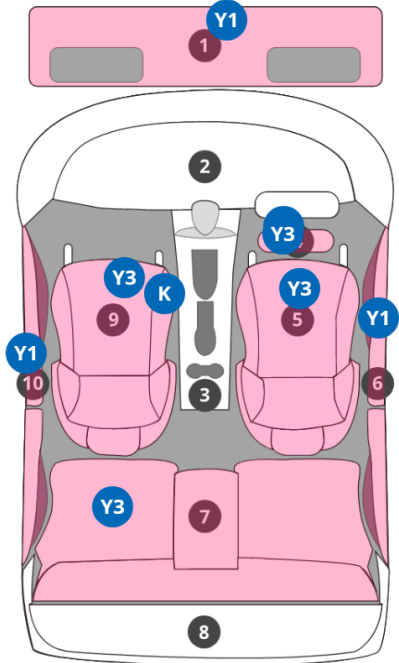
Interior Evaluation : C	Exterior Evaluation : E

<p>a : Cut, Fray d : Loose, Deformed k : Animal Hair s : Smell t : Cigarette Burns x : Defective y : Stain</p>

<p>A : Scratch AU : Scratch & Dent B : Modified C : Corrosion G : Stone chip P : Faded S : Rust SC : Rust & Corrosion U : Dent X : Defective Y : Crack, Gap</p>
<p>Remarks (R) Front Seat - Grime - Medium / (L) Front Seat - Grime - Medium / Rear Seat - Grime - Medium / Overall Interior - Animal Hair - Yes / Ceiling - Grime - Minimal / (L) Front Floor Mat - Worked - Small / (L) Front Floor Mat - Grime - Medium / (L) Front Trim - Grime - Minimal / (R) Front Trim - Grime - Minimal</p>	<p>Remarks Bonnet - Repair Traces - Yes / (R) Front Fender, Molding - Scratch & Dent - Medium / (R) Front Door, Molding - Scratch & Dent - Medium / (R) Rear Door, Molding - Scratch & Dent - Large / (R) Step, In-panel, Side Spoiler - Scratch & Dent - Medium / (R) Rear Fender, Molding - Scratch & Dent - Medium / (R) Mirror - Scratch - Small / Trunk Hood, Rear Gate - Scratch & Dent - Medium / Rear Bumper, Lamps, Panels - Scratch & Dent - Medium / (L) Rear Door, Molding - Scratch - Medium / Member (Bolted) - Dent - Yes / (L) Front Door, Molding - Scratch - Minimal / (L) Rear Fender, Molding - Scratch - Small / (L) Mirror - Scratch - Small / (L) Front Fender, Molding - Scratch - Minimal / Front Bumper, Grille, Lamps - Scratch - Large / Bonnet, Headlight - Scratch - Medium / Roof - Dent - Small</p>

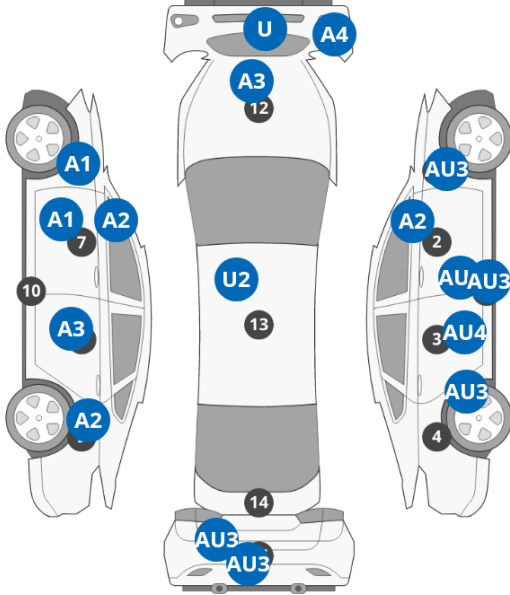
<p>Inspector Notes</p>
<p>with warranty booklet, jack and tools, with spare tire and LTO PLATE, scratches on tail light</p>
