General Information

Make	Toyota	Model	Avanza
YOM	2022	Odo Meter Reading	156,707
Registration No.	NFE3302	Chassis No.	MHFAA1BY5N0004213
CC	1.3	Transmission	CVT
Fuel Type	Gas	Type of Body	MPV
Colour	Silver

Body / Panel Condition

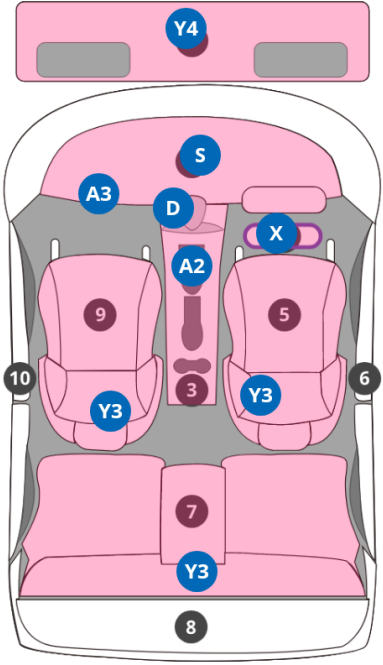
Interior Evaluation : C	Exterior Evaluation : E

<p>a : Cut, Fray d : Loose, Deformed k : Animal Hair s : Smell t : Cigarette Burns x : Defective y : Stain</p>

<p>A : Scratch AU : Scratch & Dent B : Modified C : Corrosion G : Stone chip P : Faded S : Rust SC : Rust & Corrosion U : Dent X : Defective Y : Crack, Gap</p>
<p>Remarks Overall Interior - Smell - Yes / Overall Interior - Worn as per age - Yes / (R) Front Seat - Grime - Medium / (L) Front Seat - Grime - Medium / Console, Switches, Vents - Traces of Adhesive Tape - Yes / Knobs - Worn, Peel, Crack - Small / Steering Wheel - Worn, Peel, Crack - Medium / Ceiling - Grime - Large / Rear Seat - Grime - Medium / Mat Other - Missing - Yes</p>	<p>Remarks (R) Front Fender - Repair Traces - Yes / (R) Front Fender, Molding - Scratch - Minimal / (R) Mirror - Scratch - Medium / (R) Front Door, Molding - Scratch & Dent - Small / (R) Step, In-panel, Side Spoiler - Scratch & Dent - Medium / (R) Rear Fender, Molding - Scratch & Dent - Small / Rear Bumper, Lamps, Panels - Repair mark - Yes / Rear Bumper, Lamps, Panels - Scratch - Large / Trunk Hood, Rear Gate - Scratch - Minimal / (L) Rear Fender, Molding - Scratch & Dent - Small / (L) Rear Door, Molding - Scratch & Dent - Large / (L) Step, In-panel, Side Spoiler - Scratch & Dent - Medium / (L) Mirror - Scratch - Small / Front Bumper, Grille, Lamps - Repair mark - Yes / (L) Front Door, Molding - Scratch & Dent - Small / (L) Front Fender, Molding - Scratch - Small / Front Bumper, Grille, Lamps - Scratch - Medium / Bonnet, Headlight - Scratch & Dent - Small / Roof - Dent - Large / (R) Rear Door, Molding - Scratch & Dent - Large</p>
