General Information

Make	Toyota	Model	Avanza
YOM	2025	Odo Meter Reading	21,913
Registration No.	NJF1194	Chassis No.	MHFAA1BY0R0035374
CC	1.3	Transmission	CVT
Fuel Type	Gas	Type of Body	MPV
Colour	Green

Body / Panel Condition

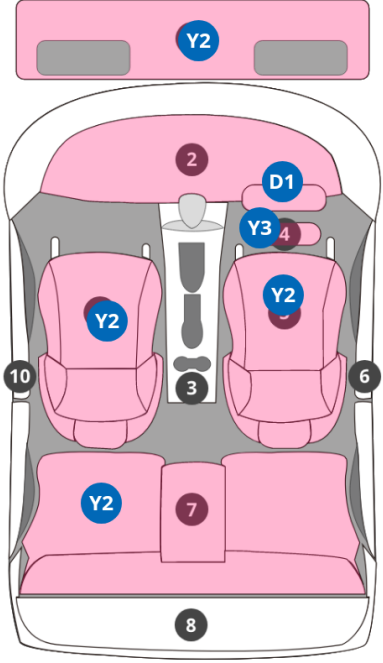
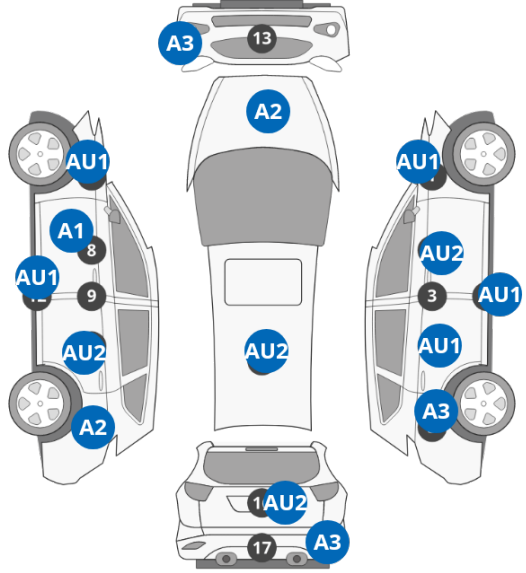
Interior Evaluation :	B	Exterior Evaluation :	C

<p>a : Cut, Fray d : Loose, Deformed k : Animal Hair s : Smell t : Cigarette Burns x : Defective y : Stain</p>		<p>A : Scratch AU : Scratch & Dent B : Modified C : Corrosion G : Stone chip P : Faded S : Rust SC : Rust & Corrosion U : Dent X : Defective Y : Crack, Gap</p>	
<p>Remarks (L) Front Floor Mat - Grime - Medium / (L) Front Seat - Grime - Small / (R) Front Seat - Grime - Small / Rear Seat - Grime - Small / Ceiling - Grime - Small / Dashboard - Worked - Minimal</p>		<p>Remarks Roof - Repair Traces - Yes / (L) Rear Door, Molding - Scratch & Dent - Small / (L) Step, In-panel, Side Spoiler - Scratch & Dent - Minimal / (L) Rear Fender, Molding - Scratch - Small / Rear Bumper, Lamps, Panels - Scratch - Medium / Trunk Hood, Rear Gate - Scratch & Dent - Small / (R) Rear Fender, Molding - Scratch - Medium / (R) Rear Door, Molding - Scratch & Dent - Minimal / (R) Step, In-panel, Side Spoiler - Scratch & Dent - Minimal / (R) Front Door, Molding - Scratch & Dent - Small / (R) Front Fender, Molding - Scratch & Dent - Minimal / Front Bumper, Grille, Lamps - Scratch - Medium / Roof - Scratch & Dent - Small / Bonnet, Headlight - Scratch - Small / (L) Front Fender, Molding - Scratch & Dent - Minimal / (L) Front Door, Molding - Scratch - Minimal</p>
