General Information

Make	Toyota	Model	Avanza
YOM	2025	Odo Meter Reading	2,527
Registration No.	NKQ1400	Chassis No.	MHFAA1BY9S0042037
CC	1.3	Transmission	CVT
Fuel Type	Gas	Type of Body	Wagon
Colour	Green

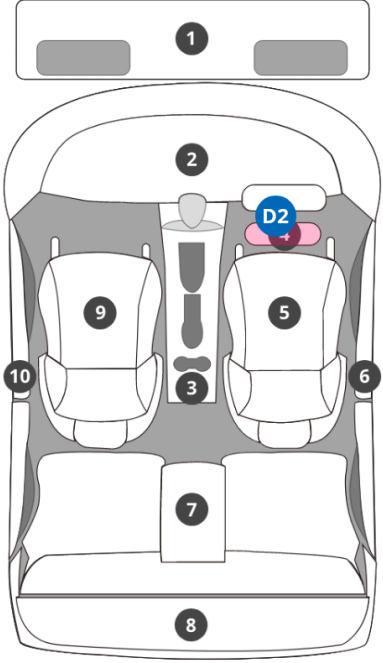
<p>a : Cut, Fray d : Loose, Deformed k : Animal Hair s : Smell t : Cigarette Burns x : Defective y : Stain</p>

<p>A : Scratch AU : Scratch & Dent B : Modified C : Corrosion G : Stone chip P : Faded S : Rust SC : Rust & Corrosion U : Dent X : Defective Y : Crack, Gap</p>
<p>Remarks (L) Front Floor Mat - Worked - Small</p>	<p>Remarks (R) Front Fender, Molding - Scratch & Dent - Small / (R) Mirror - Scratch - Minimal / (R) Front Door, Molding - Scratch - Small / (R) Rear Door, Molding - Scratch - Minimal / (R) Rear Fender, Molding - Scratch - Minimal / Rear Bumper, Lamps, Panels - Scratch - Medium / Trunk Hood, Rear Gate - Scratch - Small / (L) Rear Fender, Molding - Scratch - Small / (L) Rear Door, Molding - Scratch - Minimal / (L) Front Door, Molding - Scratch & Dent - Small / (L) Mirror - Scratch - Minimal / (L) Front Fender, Molding - Scratch & Dent - Large / Front Bumper, Grille, Lamps - Scratch & Dent - Large / Bonnet, Headlight - Crack, Gap - Medium / Roof - Scratch - Small</p>
