General Information

Make	Toyota	Model	Fortuner
YOM	2020	Odo Meter Reading	94,866
Registration No.	NGL3988	Chassis No.	MHFJB8GS0L1578638
CC	2.4	Transmission	A/T
Fuel Type	Diesel	Type of Body	SUV
Colour	Brown

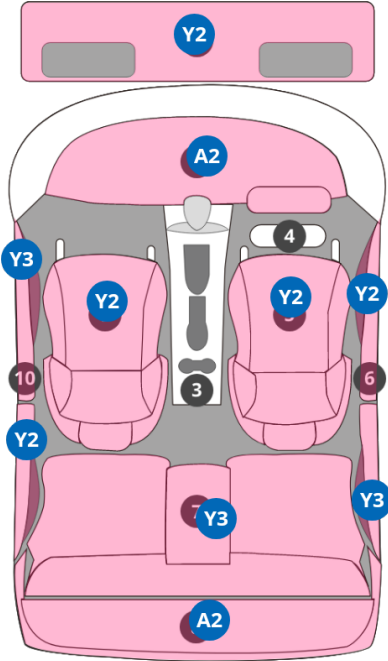
<p>a : Cut, Fray d : Loose, Deformed k : Animal Hair s : Smell t : Cigarette Burns x : Defective y : Stain</p>

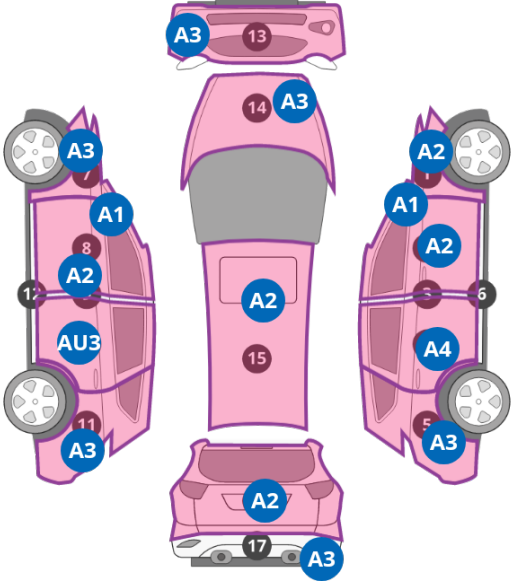
<p>A : Scratch AU : Scratch & Dent B : Modified C : Corrosion G : Stone chip P : Faded S : Rust SC : Rust & Corrosion U : Dent X : Defective Y : Crack, Gap</p>
<p>Remarks (R) Front Seat - Grime - Small / (R) Front Trim - Grime - Small / (R) Rear Trim - Grime - Medium / Rear Seat - Grime - Medium / Trunk Room - Worn, Scratch, Cut, Crack - Small / (L) Rear Trim - Grime - Small / (L) Front Trim - Grime - Medium / (L) Front Seat - Grime - Small / Ceiling - Grime - Small / Dashboard - Worn, Scratch, Cut, Crack - Small</p>	<p>Remarks (R) Front Door - Repair Traces - Yes / (R) Front Fender - Repair Traces - Yes / Bonnet - Repair Traces - Yes / (L) Front Fender - Repair Traces - Yes / (L) Front Door - Repair Traces - Yes / (L) Rear Door - Repair Traces - Yes / (L) Rear Fender - Repair Traces - Yes / Trunk Hood, Rear Gate - Repair Traces - Yes / (R) Rear Fender - Repair Traces - Yes / (R) Rear Door - Repair Traces - Yes / Roof - Repair Traces - Yes / (R) Front Door, Molding - Repair mark - Yes / Trunk Hood, Rear Gate - Repair mark - Yes / (R) Rear Door, Molding - Repair mark - Yes / (R) Rear Fender, Molding - Repair mark - Yes / (L) Rear Fender, Molding - Repair mark - Yes / (L) Rear Door, Molding - Repair mark - Yes / (L) Front Door, Molding - Repair mark - Yes / (L) Front Fender, Molding - Repair mark - Yes / Bonnet, Headlight - Repair mark - Yes / (R) Front Fender, Molding - Repair mark - Yes / Roof - Repair mark - Yes / Trunk Hood, Rear Gate - Scratch - Small / Rear Bumper, Lamps, Panels - Scratch - Medium / (R) Rear Fender, Molding - Scratch - Medium / (R) Rear Door, Molding - Scratch - Large / (R) Mirror - Scratch - Minimal / (R) Front Door, Molding - Scratch - Small / (R) Front Fender, Molding - Scratch - Small / Bonnet, Headlight - Scratch - Medium / Front Bumper, Grille, Lamps - Repair mark - Yes / Front Bumper, Grille, Lamps - Scratch - Medium / (L) Front Fender, Molding - Scratch - Medium / (L) Mirror - Scratch - Minimal / (L) Front Door, Molding - Scratch - Small / (L) Rear Door, Molding - Scratch & Dent - Medium / (L) Rear Fender, Molding - Scratch - Medium / Roof - Scratch - Small</p>
