General Information

Make	Toyota	Model	Vios
YOM	2024	Odo Meter Reading	16,613
Registration No.	DBM5752	Chassis No.	PA1B18F33R4244581
CC	1.3	Transmission	CVT
Fuel Type	Gas	Type of Body	Sedan
Colour	Blue

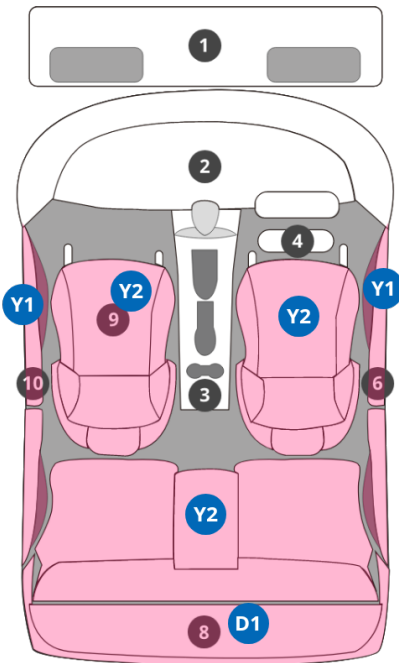
Interior Evaluation : A	Exterior Evaluation : D

<p>a : Cut, Fray d : Loose, Deformed k : Animal Hair s : Smell t : Cigarette Burns x : Defective y : Stain</p>

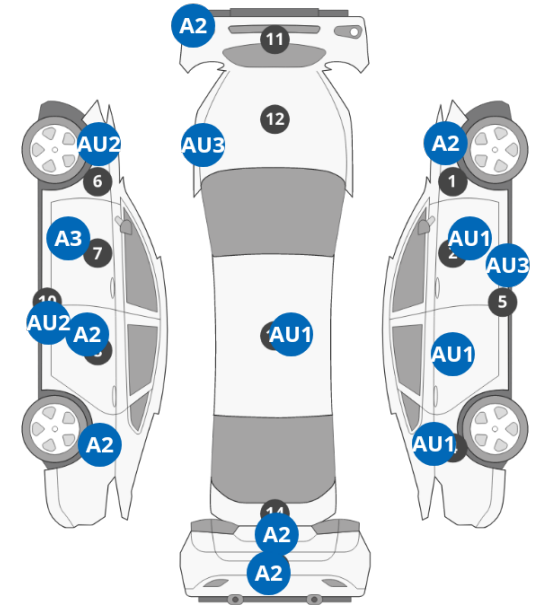
<p>A : Scratch AU : Scratch & Dent B : Modified C : Corrosion G : Stone chip P : Faded S : Rust SC : Rust & Corrosion U : Dent X : Defective Y : Crack, Gap</p>
<p>Remarks Rear Seat - Grime - Small / (L) Front Seat - Grime - Small / (R) Front Seat - Grime - Small / (R) Front Trim - Grime - Minimal / (L) Front Trim - Grime - Minimal / Trunk Room - Worked - Minimal</p>	<p>Remarks (L) Rear Door, Molding - Scratch - Small / (L) Front Door, Molding - Scratch - Medium / (L) Step, In-panel, Side Spoiler - Scratch & Dent - Small / (L) Rear Fender, Molding - Scratch - Small / Trunk Hood, Rear Gate - Scratch - Small / Rear Bumper, Lamps, Panels - Scratch - Small / (R) Rear Fender, Molding - Scratch & Dent - Minimal / Roof - Scratch & Dent - Minimal / (R) Front Door, Molding - Scratch & Dent - Minimal / (R) Step, In-panel, Side Spoiler - Scratch & Dent - Medium / (R) Front Fender, Molding - Scratch - Small / Front Bumper, Grille, Lamps - Scratch - Small / Bonnet, Headlight - Scratch & Dent - Medium / (L) Front Fender, Molding - Scratch & Dent - Small / (R) Rear Door, Molding - Scratch & Dent - Minimal</p>
