General Information

Make	Toyota	Model	Vios
YOM	2024	Odo Meter Reading	11,873
Registration No.	NFR4668	Chassis No.	PA1B18F33R4249635
CC	1.3	Transmission	CVT
Fuel Type	Gas	Type of Body	Sedan
Colour	Red Mica Metallic

Body / Panel Condition

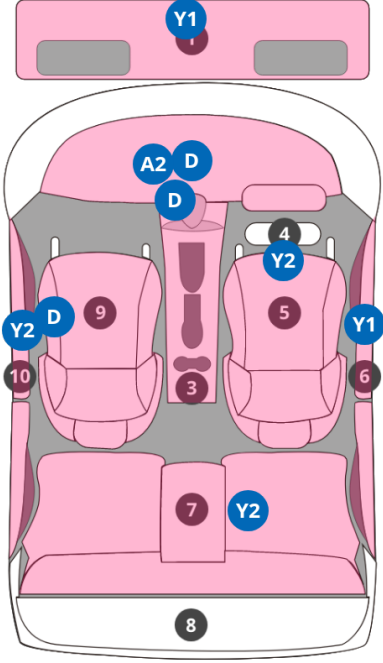
Interior Evaluation : B	Exterior Evaluation : B

<p>a : Cut, Fray d : Loose, Deformed k : Animal Hair s : Smell t : Cigarette Burns x : Defective y : Stain</p>

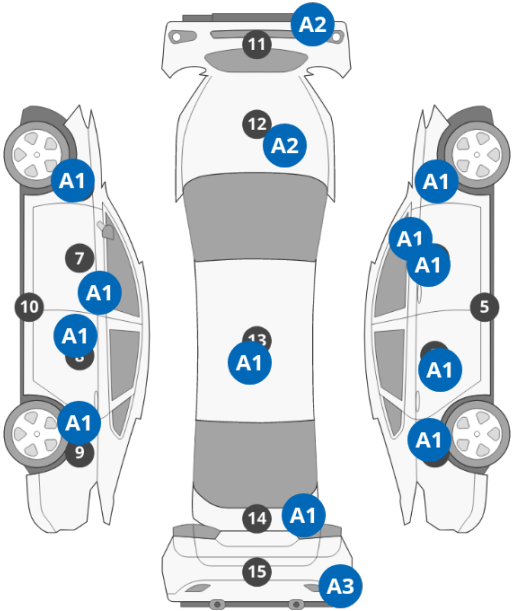
<p>A : Scratch AU : Scratch & Dent B : Modified C : Corrosion G : Stone chip P : Faded S : Rust SC : Rust & Corrosion U : Dent X : Defective Y : Crack, Gap</p>
<p>Remarks (R) Front Seat - Grime - Small / (L) Front Seat - Worn - Yes / (R) Front Trim - Grime - Minimal / (L) Front Trim - Grime - Small / Dashboard - Traces of Adhesive Tape - Yes / Console, Switches, Vents - Traces of Adhesive Tape - Yes / Rear Seat - Grime - Small / Dashboard - Worn, Scratch, Cut, Crack - Small / Ceiling - Grime - Minimal</p>	<p>Remarks (R) Front Fender, Molding - Scratch - Minimal / (R) Mirror - Scratch - Minimal / (R) Front Door, Molding - Scratch - Minimal / (R) Rear Door, Molding - Scratch - Minimal / (R) Rear Fender, Molding - Scratch - Minimal / Rear Bumper, Lamps, Panels - Scratch - Medium / Trunk Hood, Rear Gate - Scratch - Minimal / (L) Rear Fender, Molding - Scratch - Minimal / (L) Rear Door, Molding - Scratch - Minimal / (L) Front Door, Molding - Scratch - Minimal / (L) Front Fender, Molding - Scratch - Minimal / Front Bumper, Grille, Lamps - Scratch - Small / Bonnet, Headlight - Scratch - Small / Roof - Scratch - Minimal</p>

<p>Inspector Notes</p>
<p>no warranty booklet, with jack, incomplete tools, with spare tire, with LTO plate, scratches on tail light</p>
