General Information

Make	Toyota	Model	Vios
YOM	2025	Odo Meter Reading	33,869
Registration No.	NGC9163	Chassis No.	PA1B18F31R4266580
CC	1.3	Transmission	CVT
Fuel Type	Gas	Type of Body	Sedan
Colour	Black

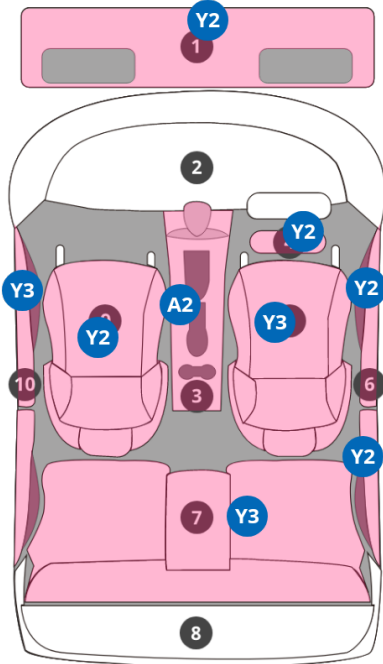
Interior Evaluation : C	Exterior Evaluation : D

<p>a : Cut, Fray d : Loose, Deformed k : Animal Hair s : Smell t : Cigarette Burns x : Defective y : Stain</p>

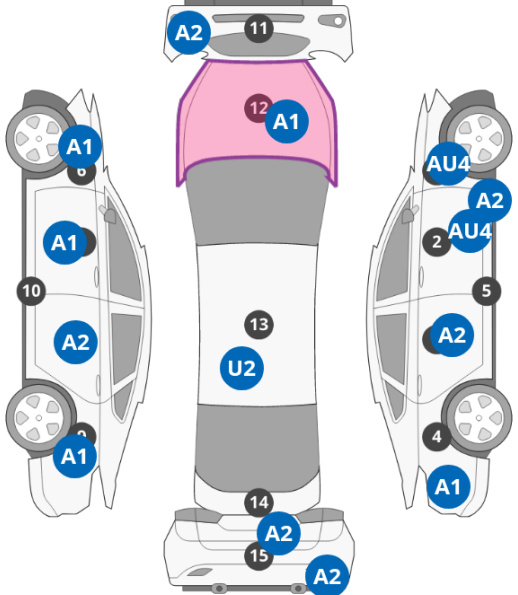
<p>A : Scratch AU : Scratch & Dent B : Modified C : Corrosion G : Stone chip P : Faded S : Rust SC : Rust & Corrosion U : Dent X : Defective Y : Crack, Gap</p>
<p>Remarks (R) Front Seat - Grime - Medium / (R) Front Trim - Grime - Small / Rear Seat - Grime - Medium / (R) Rear Trim - Grime - Small / (L) Front Trim - Grime - Medium / (L) Front Seat - Grime - Small / (L) Front Floor Mat - Grime - Small / Ceiling - Grime - Small / Console, Switchs, Vents - Worn, Scratch, Cut, Crack - Small</p>	<p>Remarks Bonnet - Repair Traces - Yes / (R) Front Fender, Molding - Scratch & Dent - Large / Bonnet, Headlight - Repair mark - Yes / (R) Front Door, Molding - Scratch & Dent - Large / (R) Step, In-panel, Side Spoiler - Scratch - Small / (R) Rear Fender, Molding - Scratch - Minimal / (R) Rear Door, Molding - Scratch - Small / Rear Bumper, Lamps, Panels - Scratch - Small / Trunk Hood, Rear Gate - Scratch - Small / (L) Rear Door, Molding - Scratch - Small / (L) Rear Fender, Molding - Scratch - Minimal / (L) Front Door, Molding - Scratch - Minimal / (L) Front Fender, Molding - Scratch - Minimal / Front Bumper, Grille, Lamps - Scratch - Small / Bonnet, Headlight - Scratch - Minimal / Roof - Dent - Small</p>
