General Information

Date & Time: 07, Jan, 2026 09:53

Make	Toyota	Model	Veloz
YOM	2024	Odo Meter Reading	21,797
Registration No.	NHS5342	Chassis No.	MHFAB1BY7R3103486
CC	1.5	Transmission	CVT
Fuel Type	Gas	Type of Body	SUV
Colour	Silver

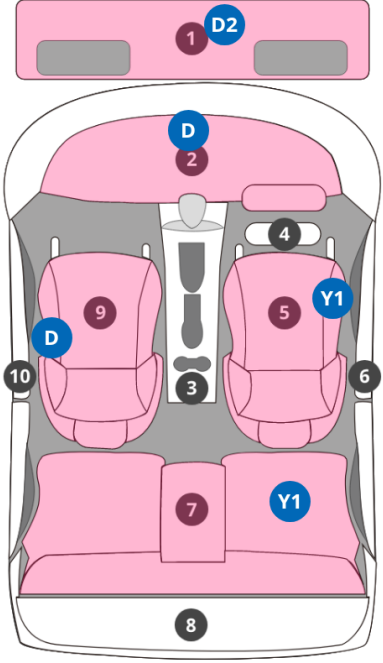
Interior Evaluation : B	Exterior Evaluation : C

<p>a : Cut, Fray d : Loose, Deformed k : Animal Hair s : Smell t : Cigarette Burns x : Defective y : Stain</p>

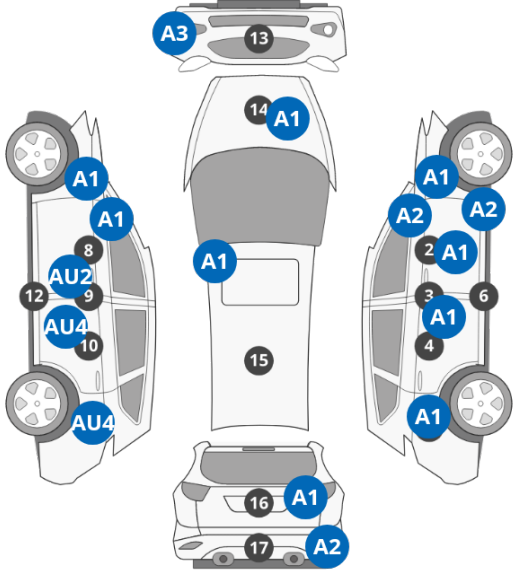
<p>A : Scratch AU : Scratch & Dent B : Modified C : Corrosion G : Stone chip P : Faded S : Rust SC : Rust & Corrosion U : Dent X : Defective Y : Crack, Gap</p>
<p>Remarks Ceiling - Crinkle - Small / Dashboard - Traces of Adhesive Tape - Yes / (R) Front Seat - Grime - Minimal / Rear Seat - Grime - Minimal / (L) Front Seat - Worn - Yes</p>	<p>Remarks (R) Front Fender, Molding - Scratch - Minimal / (R) Mirror - Scratch - Small / (R) Step, In-panel, Side Spoiler - Scratch - Small / (R) Front Door, Molding - Scratch - Minimal / (R) Rear Door, Molding - Scratch - Minimal / (R) Rear Fender, Molding - Scratch - Minimal / Rear Bumper, Lamps, Panels - Scratch - Small / Trunk Hood, Rear Gate - Scratch - Minimal / (L) Rear Fender, Molding - Scratch & Dent - Large / (L) Front Door, Molding - Scratch & Dent - Small / (L) Rear Door, Molding - Scratch & Dent - Large / (L) Mirror - Scratch - Minimal / (L) Front Fender, Molding - Scratch - Minimal / Front Bumper, Grille, Lamps - Scratch - Medium / Bonnet, Headlight - Scratch - Minimal / Roof - Scratch - Minimal</p>

<p>Inspector Notes</p>
<p>with warranty booklet, jack and tools, with spare tire, with LTO plate, scratches on headlight and tail light</p>
