General Information

Make	Toyota	Model	Hiace
YOM	2023	Odo Meter Reading	24,503
Registration No.	NIM7444	Chassis No.	JTFPA9AP4P8032349
CC	2.8	Transmission	M/T
Fuel Type	Diesel	Type of Body	Van
Colour	Black

Body / Panel Condition

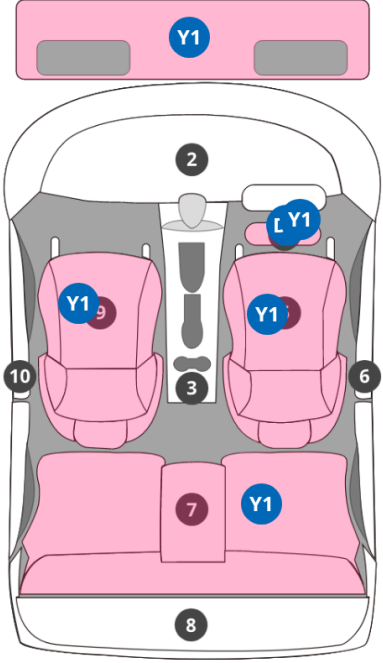
Interior Evaluation : A	Exterior Evaluation : D

<p>a : Cut, Fray d : Loose, Deformed k : Animal Hair s : Smell t : Cigarette Burns x : Defective y : Stain</p>

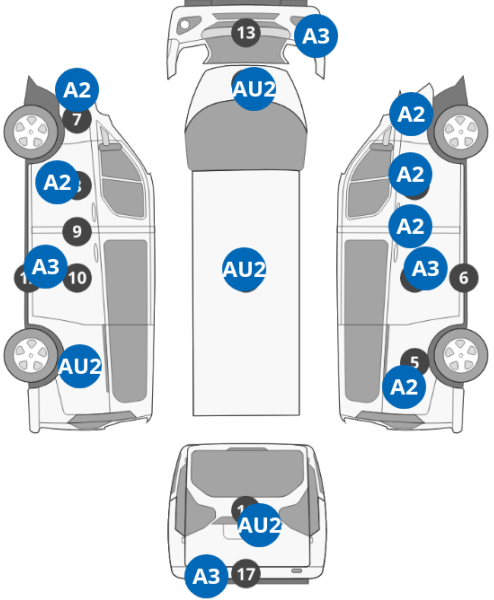
<p>A : Scratch AU : Scratch & Dent B : Modified C : Corrosion G : Stone chip P : Faded S : Rust SC : Rust & Corrosion U : Dent X : Defective Y : Crack, Gap</p>
<p>Remarks (R) Front Floor Mat - Worked - Small / (L) Front Floor Mat - Grime - Minimal / Ceiling - Grime - Minimal / Rear Seat - Grime - Minimal / (L) Front Seat - Grime - Minimal / (R) Front Seat - Grime - Minimal</p>	<p>Remarks (R) Front Fender, Molding - Scratch - Small / Bonnet, Headlight - Scratch & Dent - Small / Front Bumper, Grille, Lamps - Scratch - Medium / (L) Front Fender, Molding - Scratch - Small / (L) Front Door, Molding - Scratch - Small / (L) Rear Door, Molding - Scratch - Medium / (L) Rear Fender, Molding - Scratch & Dent - Small / Trunk Hood, Rear Gate - Scratch & Dent - Small / Rear Bumper, Lamps, Panels - Scratch - Medium / (R) Rear Fender, Molding - Scratch - Small / (R) Rear Door, Molding - Scratch - Medium / (R) Front Door, Molding - Scratch - Small / (R) Center Panel - Scratch - Small / Roof - Scratch & Dent - Small</p>
