General Information

Make	Toyota	Model	Fortuner
YOM	2025	Odo Meter Reading	27,951
Registration No.	NJC2261	Chassis No.	MHFCB3GS3R0498163
CC	2.4	Transmission	A/T
Fuel Type	Diesel	Type of Body	Wagon
Colour	Silver

Body / Panel Condition

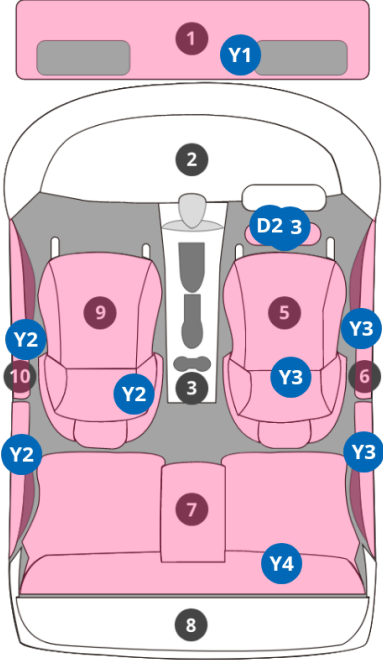
Interior Evaluation : D	Exterior Evaluation : C

<p>a : Cut, Fray d : Loose, Deformed k : Animal Hair s : Smell t : Cigarette Burns x : Defective y : Stain</p>

<p>A : Scratch AU : Scratch & Dent B : Modified C : Corrosion G : Stone chip P : Faded S : Rust SC : Rust & Corrosion U : Dent X : Defective Y : Crack, Gap</p>
<p>Remarks Mat Other - Grime - Large / Rear Seat - Grime - Large / (R) Front Seat - Grime - Medium / (L) Front Seat - Grime - Small / (R) Front Trim - Grime - Medium / (R) Front Floor Mat - Grime - Medium / (L) Front Trim - Grime - Small / (L) Rear Trim - Grime - Small / (R) Rear Trim - Grime - Medium / Ceiling - Grime - Minimal / (L) Front Floor Mat - Worked - Small</p>	<p>Remarks (R) Front Fender, Molding - Scratch - Medium / (R) Mirror - Scratch - Minimal / (R) Front Door, Molding - Scratch - Small / (R) Rear Door, Molding - Scratch - Small / Rear Bumper, Lamps, Panels - Scratch & Dent - Medium / (R) Rear Fender, Molding - Scratch - Minimal / Trunk Hood, Rear Gate - Scratch - Minimal / (L) Rear Fender, Molding - Scratch - Minimal / (L) Rear Door, Molding - Scratch - Minimal / (L) Front Door, Molding - Scratch - Small / (L) Mirror - Scratch - Minimal / (L) Front Fender, Molding - Scratch - Small / Bonnet, Headlight - Scratch - Minimal / Roof - Scratch & Dent - Minimal / Front Bumper, Grille, Lamps - Crack, Gap - Large</p>

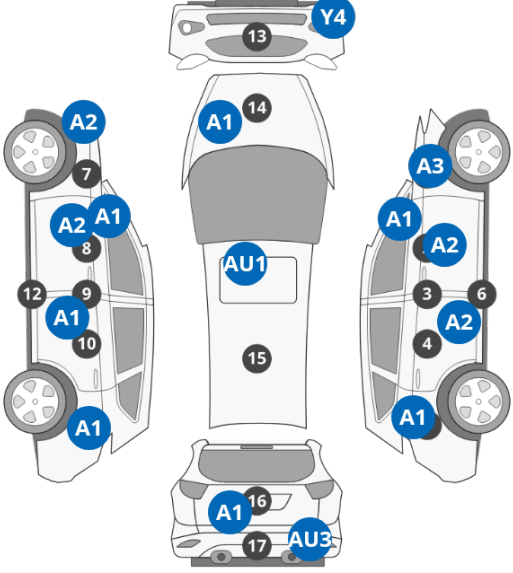
<p>Inspector Notes</p>
<p>with warranty booklet, jack and tools, with spare tire and LTO PLATE, scratched and cracked tail light, fog lamp issue</p>
