General Information

Make	Ford	Model	Ranger
YOM	2019	Odo Meter Reading	75,676
Registration No.	CAR5196	Chassis No.	MPBUMFE60KX228625
CC	2.0	Transmission	A/T
Fuel Type	Diesel	Type of Body	Pickup
Colour	Red

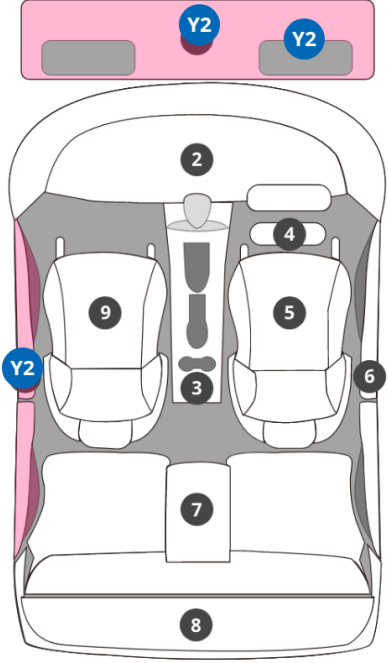
<p>a : Cut, Fray d : Loose, Deformed k : Animal Hair s : Smell t : Cigarette Burns x : Defective y : Stain</p>

<p>A : Scratch AU : Scratch & Dent B : Modified C : Corrosion G : Stone chip P : Faded S : Rust SC : Rust & Corrosion U : Dent X : Defective Y : Crack, Gap</p>
<p>Remarks Sunvisor, Sunglass Holder - Grime - Small / Ceiling - Grime - Small / (L) Front Trim - Grime - Small</p>	<p>Remarks (R) Mirror - Scratch - Small / (R) Rear Corner Panel - Scratch - Small / Rear Gate - Scratch & Dent - Small / (L) Rear Corner Panel - Scratch - Minimal / (L) Front Door, Molding - Scratch - Small / (L) Rear Door, Molding - Scratch - Medium / (L) Mirror - Scratch - Small / (R) Front Fender, Molding - Scratch - Medium / Front Bumper, Grille, Lamps - Scratch - Small / (L) Side Gate - Scratch - Small</p>
Frame Evaluation : A	Functional Evaluation : A
