## General Information

<b>Make</b>	Honda	<b>Model</b>	City
<b>YOM</b>	2018	<b>Odo Meter Reading</b>	145,863
<b>Registration No.</b>	NCU2593	<b>Chassis No.</b>	PADGM6620JV412572
<b>CC</b>	1.5	<b>Transmission</b>	A/T
<b>Fuel Type</b>	Gas	<b>Type of Body</b>	Sedan
<b>Colour</b>	Black

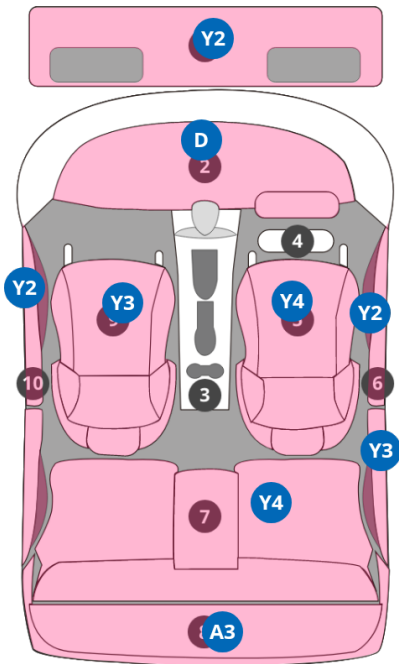
<b>Interior Evaluation :</b> <span style="float: right;"><b>D</b></span>	<b>Exterior Evaluation :</b> <span style="float: right;"><b>E</b></span>

<p><b>a</b> : Cut, Fray <b>d</b> : Loose, Deformed <b>k</b> : Animal Hair <b>s</b> : Smell <b>t</b> : Cigarette Burns <b>x</b> : Defective <b>y</b> : Stain</p>

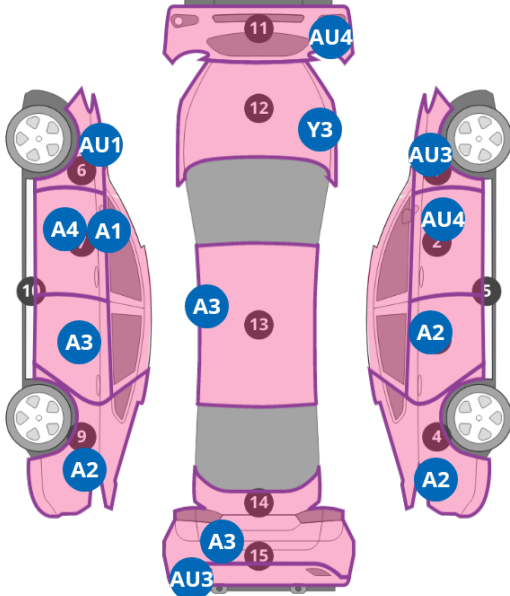
<p><b>A</b> : Scratch <b>AU</b> : Scratch &amp; Dent <b>B</b> : Modified <b>C</b> : Corrosion <b>G</b> : Stone chip <b>P</b> : Faded <b>S</b> : Rust <b>SC</b> : Rust &amp; Corrosion <b>U</b> : Dent <b>X</b> : Defective <b>Y</b> : Crack, Gap</p>
<b>Remarks</b> (R) Front Seat - Grime - Large / (R) Front Trim - Grime - Small / Rear Seat - Grime - Large / (R) Rear Trim - Grime - Medium / (L) Front Trim - Grime - Small / (L) Front Seat - Grime - Medium / Trunk Room - Worn, Scratch, Cut, Crack - Medium / Ceiling - Grime - Small / Dashboard - Traces of Adhesive Tape - Yes	<b>Remarks</b> (R) Front Door - Repair Traces - Yes / (R) Front Fender - Repair Traces - Yes / Bonnet - Repair Traces - Yes / (L) Front Fender - Repair Traces - Yes / (L) Front Door - Repair Traces - Yes / (L) Rear Door - Repair Traces - Yes / (L) Rear Fender - Repair Traces - Yes / Trunk Hood, Rear Gate - Repair Traces - Yes / (R) Rear Fender - Repair Traces - Yes / (R) Rear Door - Repair Traces - Yes / Roof - Repair Traces - Yes / (L) Front Door, Molding - Repair mark - Yes / (L) Rear Door, Molding - Repair mark - Yes / (L) Rear Fender, Molding - Repair mark - Yes / Trunk Hood, Rear Gate - Repair mark - Yes / Roof - Repair mark - Yes / (R) Rear Fender, Molding - Repair mark - Yes / (R) Rear Door, Molding - Repair mark - Yes / (R) Front Door, Molding - Repair mark - Yes / Bonnet, Headlight - Repair mark - Yes / Front Bumper, Grille, Lamps - Repair mark - Yes / Rear Bumper, Lamps, Panels - Repair mark - Yes / Trunk Hood, Rear Gate - Scratch - Medium / Rear Bumper, Lamps, Panels - Scratch & Dent - Medium / (L) Rear Fender, Molding - Scratch - Small / (L) Rear Door, Molding - Scratch - Medium / (L) Front Door, Molding - Scratch - Large / (L) Mirror - Scratch - Minimal / (L) Front Fender, Molding - Repair mark - Yes / (R) Front Fender, Molding - Repair mark - Yes / (L) Front Fender, Molding - Scratch & Dent - Minimal / Front Bumper, Grille, Lamps - Scratch & Dent - Large / Bonnet, Headlight - Crack, Gap - Medium / (R) Front Fender, Molding - Scratch & Dent - Medium / (R) Front Door, Molding - Scratch & Dent - Large / (R) Rear Door, Molding - Scratch - Small / (R) Rear Fender, Molding - Scratch - Small / Roof - Scratch - Medium
