General Information

Make	Toyota	Model	Vios
YOM	2024	Odo Meter Reading	60,758
Registration No.	FAQ3617	Chassis No.	PA1B18F37P4231491
CC	1.3	Transmission	CVT
Fuel Type	Gas	Type of Body	Sedan
Colour	Blue

Body / Panel Condition

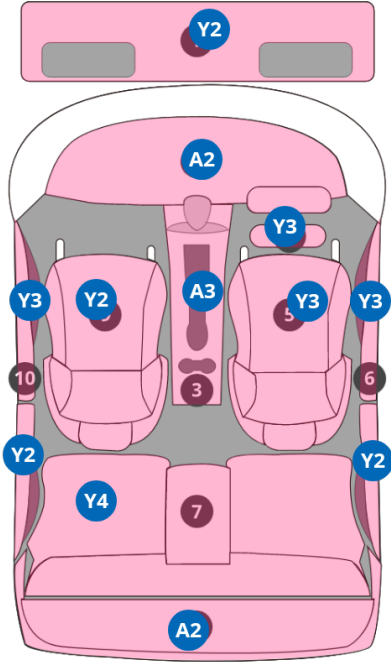
Interior Evaluation : E	Exterior Evaluation : C

<p>a : Cut, Fray d : Loose, Deformed k : Animal Hair s : Smell t : Cigarette Burns x : Defective y : Stain</p>

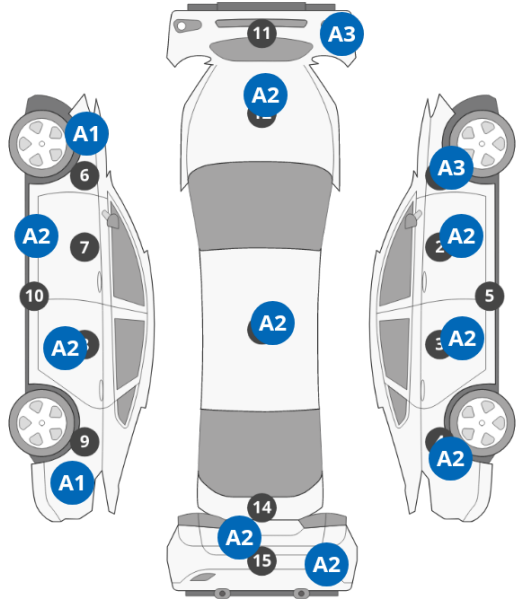
<p>A : Scratch AU : Scratch & Dent B : Modified C : Corrosion G : Stone chip P : Faded S : Rust SC : Rust & Corrosion U : Dent X : Defective Y : Crack, Gap</p>
Remarks (L) Front Trim - Grime - Medium / (L) Front Seat - Grime - Small / (L) Front Floor Mat - Grime - Medium / (L) Rear Trim - Grime - Small / Rear Seat - Grime - Large / (R) Rear Trim - Grime - Small / (R) Front Seat - Grime - Medium / Ceiling - Grime - Small / Console, Switches, Vents - Worn, Scratch, Cut, Crack - Medium / Dashboard - Worn, Scratch, Cut, Crack - Small / (R) Front Trim - Grime - Medium / Trunk Room - Worn, Scratch, Cut, Crack - Small	Remarks (L) Front Door, Molding - Scratch - Small / (L) Rear Door, Molding - Scratch - Small / (L) Rear Fender, Molding - Scratch - Minimal / Trunk Hood, Rear Gate - Scratch - Small / Rear Bumper, Lamps, Panels - Scratch - Small / (R) Rear Fender, Molding - Scratch - Small / (R) Rear Door, Molding - Scratch - Small / (R) Front Door, Molding - Scratch - Small / (R) Front Fender, Molding - Scratch - Medium / Front Bumper, Grille, Lamps - Scratch - Medium / Bonnet, Headlight - Scratch - Small / Roof - Scratch - Small / (L) Front Fender, Molding - Scratch - Minimal
