General Information

Make	Toyota	Model	Hiace
YOM	2019	Odo Meter Reading	114,626
Registration No.	NBE9105	Chassis No.	JTFJT02P3J5018932
CC	3.0	Transmission	M/T
Fuel Type	Diesel	Type of Body	Van
Colour	Silver

Body / Panel Condition

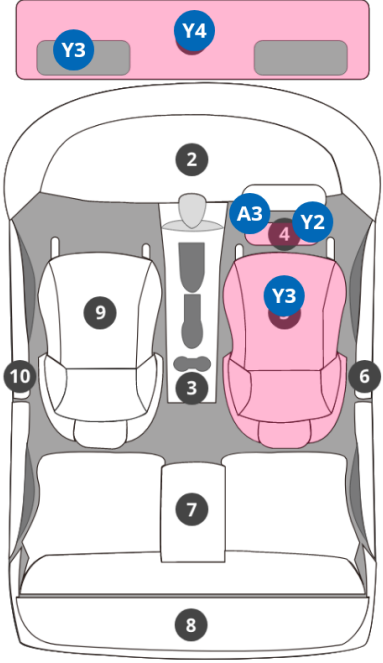
Interior Evaluation :	C	Exterior Evaluation :	E

<p>a : Cut, Fray d : Loose, Deformed k : Animal Hair s : Smell t : Cigarette Burns x : Defective y : Stain</p>		<p>A : Scratch AU : Scratch & Dent B : Modified C : Corrosion G : Stone chip P : Faded S : Rust SC : Rust & Corrosion U : Dent X : Defective Y : Crack, Gap</p>	
<p>Remarks (R) Front Floor Mat - Grime - Small / Ceiling - Grime - Large / (L) Front Floor Mat - Cut, Crack - Medium / (R) Front Seat - Grime - Medium / Sunvisor, Sunglass Holder - Grime - Medium</p>		<p>Remarks Trunk Hood, Rear Gate - Repair Traces - Yes / (R) Front Door, Molding - Scratch & Dent - Small / (R) Center Panel - Scratch & Dent - Small / (R) Rear Door, Molding - Scratch - Large / (R) Rear Fender, Molding - Scratch & Dent - Large / Trunk Hood, Rear Gate - Scratch & Dent - Small / Rear Bumper, Lamps, Panels - Scratch & Dent - Large / (L) Rear Fender, Molding - Scratch - Small / (L) Front Door, Molding - Scratch - Small / (L) Front Fender, Molding - Scratch - Small / (L) Mirror - Scratch - Small / (R) Front Fender, Molding - Scratch - Small / (R) Mirror - Scratch - Small / Bonnet, Headlight - Scratch & Dent - Small / Front Bumper, Grille, Lamps - Crack, Gap - Large / Roof - Scratch - Medium</p>

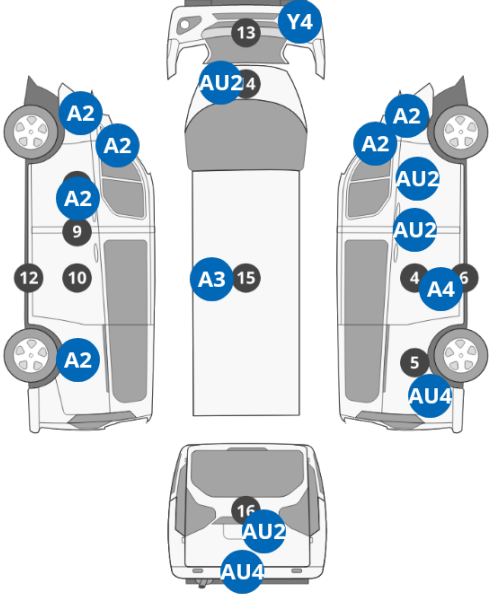
Inspector Notes
<p>Crack front and rear bumper. Plate light issue. Brake pedal issue. Aftermarket foglight issue. With warranty booklet and spare tire. Without jack, tools and seat cover. 1 key. With LTO plate.</p>
