General Information

Make	Toyota	Model	Vios
YOM	2023	Odo Meter Reading	50,139
Registration No.	NFB2237	Chassis No.	PA1B18F33P4208600
CC	1.3	Transmission	CVT
Fuel Type	Gas	Type of Body	Sedan
Colour	Black

Body / Panel Condition

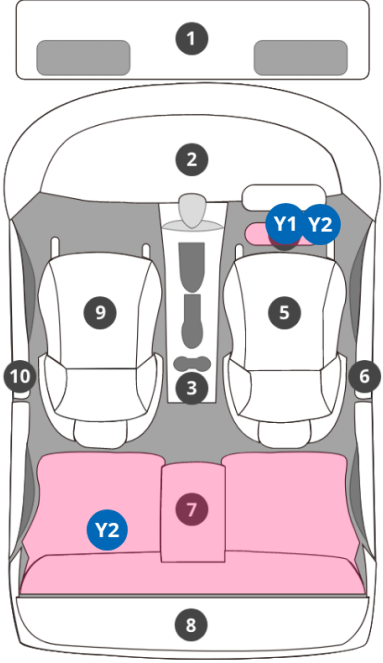
Interior Evaluation : A	Exterior Evaluation : D

<p>a : Cut, Fray d : Loose, Deformed k : Animal Hair s : Smell t : Cigarette Burns x : Defective y : Stain</p>

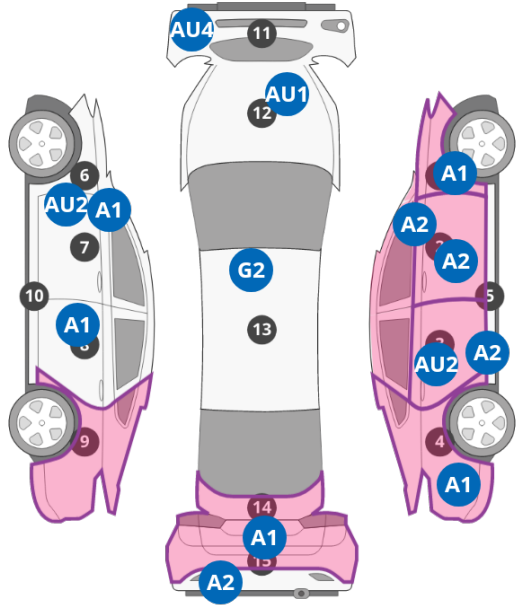
<p>A : Scratch AU : Scratch & Dent B : Modified C : Corrosion G : Stone chip P : Faded S : Rust SC : Rust & Corrosion U : Dent X : Defective Y : Crack, Gap</p>
<p>Remarks (L) Front Floor Mat - Grime - Minimal / (R) Front Floor Mat - Grime - Small / Rear Seat - Grime - Small</p>	<p>Remarks (R) Front Fender - Repair Traces - Yes / Trunk Hood, Rear Gate - Repair Traces - Yes / (R) Front Fender, Molding - Repair mark - Yes / (R) Front Fender, Molding - Scratch - Minimal / (R) Mirror - Scratch - Small / (R) Front Door, Molding - Repair mark - Yes / (R) Front Door, Molding - Scratch - Small / (R) Rear Door, Molding - Repair mark - Yes / (R) Step, In-panel, Side Spoiler - Scratch - Small / (R) Rear Fender, Molding - Repair mark - Yes / (R) Rear Door, Molding - Scratch & Dent - Small / (R) Rear Fender, Molding - Scratch - Minimal / Trunk Hood, Rear Gate - Repair mark - Yes / Trunk Hood, Rear Gate - Scratch - Minimal / (L) Rear Fender, Molding - Repair mark - Yes / Rear Bumper, Lamps, Panels - Scratch - Small / (L) Rear Door, Molding - Scratch - Minimal / (L) Front Door, Molding - Scratch & Dent - Small / (L) Mirror - Scratch - Minimal / Front Bumper, Grille, Lamps - Scratch & Dent - Large / Bonnet, Headlight - Scratch & Dent - Minimal / Front Windshield - Scratch, Stone chip - Small</p>

<p>Inspector Notes</p>
<p>With Lto plate, with spare tire, 1key, no warranty booklet, no jack and tools, scratches on headlights and taillights</p>
