General Information

Make	Mitsubishi	Model	Mirage
YOM	2018	Odo Meter Reading	49,257
Registration No.	NEI1917	Chassis No.	PAEA13TXJJA005542
CC	1.2	Transmission	A/T
Fuel Type	Gas	Type of Body	Sedan
Colour	Black

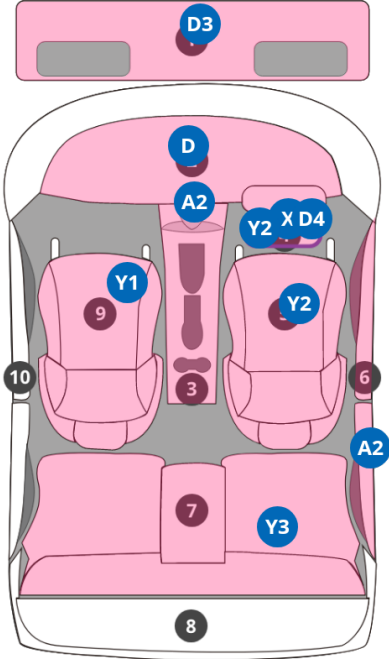
Interior Evaluation : C	Exterior Evaluation : E

<p>a : Cut, Fray d : Loose, Deformed k : Animal Hair s : Smell t : Cigarette Burns x : Defective y : Stain</p>

<p>A : Scratch AU : Scratch & Dent B : Modified C : Corrosion G : Stone chip P : Faded S : Rust SC : Rust & Corrosion U : Dent X : Defective Y : Crack, Gap</p>
<p>Remarks Ceiling - Loose, Deformed - Medium / (R) Front Seat - Grime - Small / Rear Seat - Grime - Medium / Mat Other - Missing - Yes / (R) Rear Trim - Cut, Crack - Small / (L) Front Floor Mat - Grime - Small / Carpet - Worked - Large / (L) Front Seat - Grime - Minimal / Knobs - Worn, Peel, Crack - Small / Dashboard - Traces of Adhesive Tape - Yes</p>	<p>Remarks (R) Front Door - Repair Traces - Yes / (R) Front Fender - Repair Traces - Yes / Bonnet - Repair Traces - Yes / (L) Front Fender - Repair Traces - Yes / (L) Front Door - Repair Traces - Yes / (L) Rear Door - Repair Traces - Yes / (L) Rear Fender - Repair Traces - Yes / Trunk Hood, Rear Gate - Repair Traces - Yes / (R) Rear Fender - Repair Traces - Yes / (R) Rear Door - Repair Traces - Yes / Roof - Repair Traces - Yes / Overall Exterior - Full Re-Paint in same color - Yes / (R) Front Fender, Molding - Scratch & Dent - Medium / (R) Mirror - Scratch - Small / (R) Front Door, Molding - Scratch & Dent - Minimal / (R) Front Fender, Molding - Repair mark - Yes / (R) Front Door, Molding - Repair mark - Yes / (R) Rear Door, Molding - Scratch - Minimal / (R) Rear Fender, Molding - Scratch & Dent - Small / Trunk Hood, Rear Gate - Scratch - Small / Rear Bumper, Lamps, Panels - Scratch - Small / (L) Rear Fender, Molding - Scratch & Dent - Minimal / (L) Rear Fender, Molding - Repair mark - Yes / (L) Rear Door, Molding - Scratch & Dent - Small / (L) Front Door, Molding - Repair mark - Yes / (L) Front Door, Molding - Scratch - Medium / (L) Step, In-panel, Side Spoiler - Scratch - Minimal / (L) Front Fender, Molding - Repair mark - Yes / (L) Front Fender, Molding - Scratch - Small / Front Bumper, Grille, Lamps - Crack, Gap - Large / Front Windshield - Damaged - Large / Bonnet, Headlight - Scratch - Small / Roof - Scratch - Minimal</p>
