General Information

Make	Mitsubishi	Model	Mirage
YOM	2024	Odo Meter Reading	21,280
Registration No.	NKJ6000	Chassis No.	PAEA13RJRRRA006726
CC	1.2	Transmission	CVT
Fuel Type	Gas	Type of Body	Sedan
Colour	Gray

Body / Panel Condition

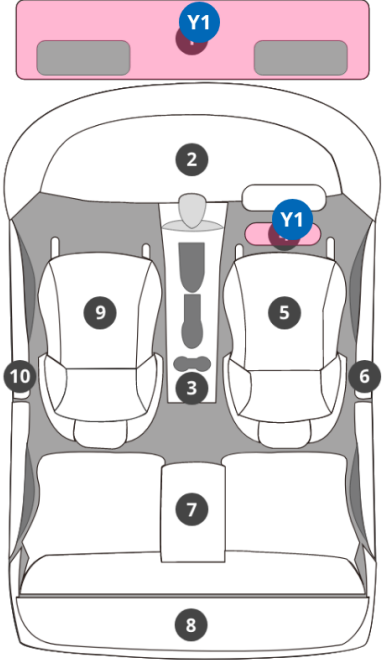
Interior Evaluation : A	Exterior Evaluation : D

<p>a : Cut, Fray d : Loose, Deformed k : Animal Hair s : Smell t : Cigarette Burns x : Defective y : Stain</p>

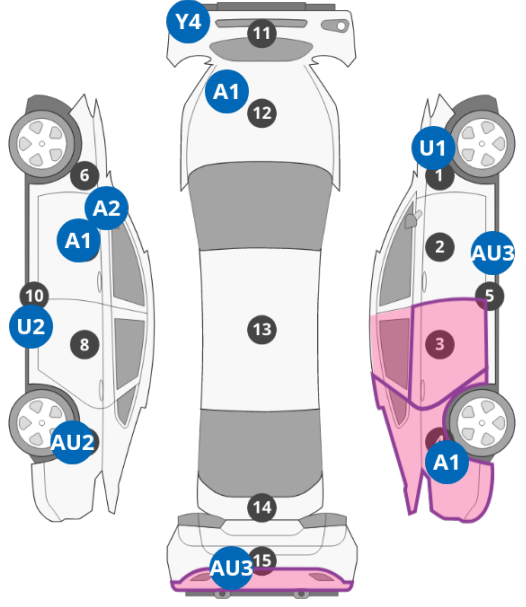
<p>A : Scratch AU : Scratch & Dent B : Modified C : Corrosion G : Stone chip P : Faded S : Rust SC : Rust & Corrosion U : Dent X : Defective Y : Crack, Gap</p>
Remarks Ceiling - Grime - Minimal / Mat Other - Grime - Minimal	Remarks (R) Rear Fender - Repair Traces - Yes / (R) Rear Door - Repair Traces - Yes / (R) Front Fender, Molding - Dent - Minimal / (R) Step, In-panel, Side Spoiler - Scratch & Dent - Medium / (R) Rear Door, Molding - Repair mark - Difference in Color / (R) Rear Fender, Molding - Repair mark - Difference in Color / (R) Rear Fender, Molding - Scratch - Minimal / Rear Bumper, Lamps, Panels - Scratch & Dent - Medium / Rear Bumper, Lamps, Panels - Repair mark - Difference in Color / (L) Rear Fender, Molding - Scratch & Dent - Small / (L) Step, In-panel, Side Spoiler - Dent - Small / (L) Mirror - Scratch - Small / (L) Front Door, Molding - Scratch - Minimal / Front Bumper, Grille, Lamps - Crack, Gap - Large / Bonnet, Headlight - Scratch - Minimal

Inspector Notes
With Lto plate, with spare tire and jack, 1key, no warranty booklet, no tools, scratches on headlight and taillight
