## General Information

| Make | Toyota | Model | Hiace |
| Registration No. | GAW4108 | Chassis No. | JTFNAFAP4N8023945 |

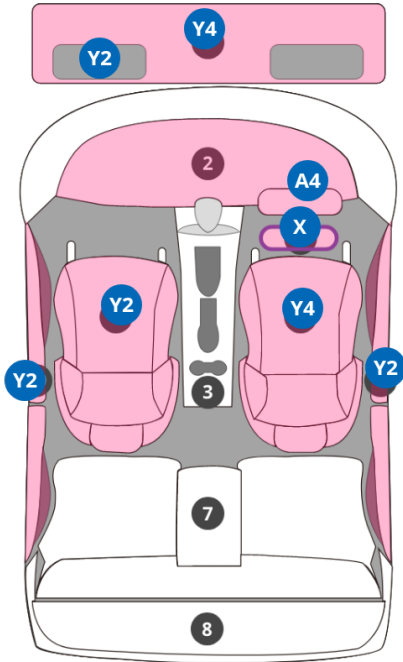
| Interior Evaluation : <b>C</b> | Exterior Evaluation : <b>E</b> |
| <p><b>Remarks</b></p> <p>(R) Front Seat - Grime - Large / Mat Other - Missing - Yes / Ceiling - Grime - Large / Steering Wheel - Worn, Peel, Crack - Large / Sunvisor, Sunglass Holder - Grime - Small / Trim Other - Grime - Small / Trim Other - Grime - Small / (L) Front Seat - Grime - Small</p> | <p><b>Remarks</b></p> <p>(R) Front Door - Repair Traces - Yes / (R) Step - Repair Traces - Yes / (R) Front Fender - Repair Traces - Yes / Bonnet - Repair Traces - Yes / (L) Front Fender - Repair Traces - Yes / (L) Front Door - Repair Traces - Yes / (L) Step - Repair Traces - Yes / (L) Rear Fender - Repair Traces - Yes / (R) Rear Fender - Repair Traces - Yes / (R) Rear Door - Repair Traces - Yes / (R) Center Panel - Repair Traces - Yes / (L) Rear Fender, Molding - Scratch &amp; Dent - Large / Trunk Hood, Rear Gate - Scratch &amp; Dent - Medium / Rear Bumper, Lamps, Panels - Scratch &amp; Dent - Large / (L) Front Door, Molding - Scratch - Medium / (L) Mirror - Scratch - Medium / (L) Center Panel - Scratch - Small / (L) Front Fender, Molding - Scratch - Small / Bonnet, Headlight - Scratch - Large / Front Bumper, Grille, Lamps - Scratch &amp; Dent - Large / (R) Front Fender, Molding - Scratch - Large / (R) Mirror - Scratch - Medium / (R) Front Door, Molding - Scratch - Medium / (R) Center Panel - Scratch - Medium / (R) Rear Door, Molding - Scratch &amp; Dent - Large / (R) Rear Fender, Molding - Scratch - Medium / Roof - Repair mark - Yes / Overall Exterior - Faded(Color, Gloss) - Yes</p> |

| Inspector Notes |
|---|
| <p>ABS warning lamp on. Battery for replacement. Engine oil for replacement. Without warranty booklet, jack and tools. With spare tire. Incomplete seat cover. 1 key. No LTO plate.</p> |
