General Information

Make	Toyota	Model	Hiace
YOM	2022	Odo Meter Reading	274,573
Registration No.	GAW4024	Chassis No.	JTFNAFAPXN8023948
CC	2.8	Transmission	M/T
Fuel Type	Diesel	Type of Body	Van
Colour	Black

Body / Panel Condition

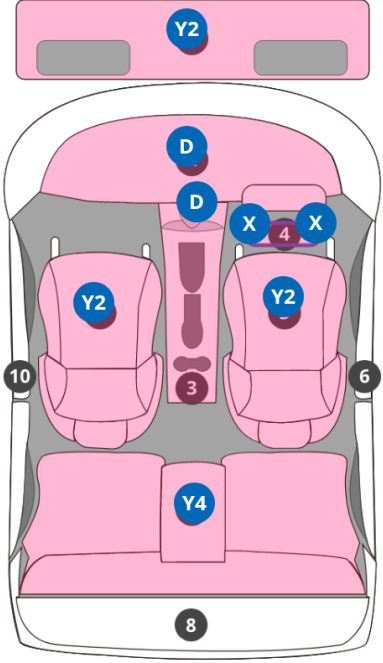
Interior Evaluation : C	Exterior Evaluation : E

<p>a : Cut, Fray d : Loose, Deformed k : Animal Hair s : Smell t : Cigarette Burns x : Defective y : Stain</p>

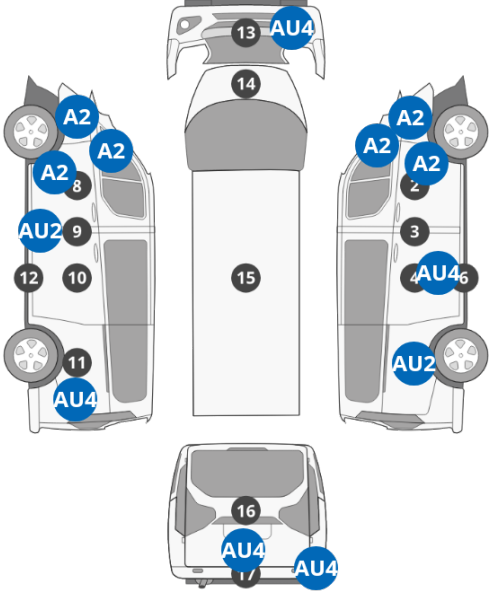
<p>A : Scratch AU : Scratch & Dent B : Modified C : Corrosion G : Stone chip P : Faded S : Rust SC : Rust & Corrosion U : Dent X : Defective Y : Crack, Gap</p>
<p>Remarks (L) Front Floor Mat - Missing - Yes / (R) Front Floor Mat - Missing - Yes / Console, Switches, Vents - Traces of Adhesive Tape - Yes / Dashboard - Traces of Adhesive Tape - Yes / (R) Front Seat - Grime - Small / Rear Seat - Grime - Large / (L) Front Seat - Grime - Small / Ceiling - Grime - Small</p>	<p>Remarks (R) Front Door - Repair Traces - Yes / (R) Front Fender - Repair Traces - Yes / Bonnet - Repair Traces - Yes / (L) Front Fender - Repair Traces - Yes / (L) Front Door - Repair Traces - Yes / (L) Center Panel - Repair Traces - Yes / (L) Rear Door - Repair Traces - Yes / (L) Rear Fender - Repair Traces - Yes / Trunk Hood, Rear Gate - Repair Traces - Yes / (R) Rear Fender - Repair Traces - Yes / (R) Rear Door - Repair Traces - Yes / (R) Center Panel - Repair Traces - Yes / Roof - Repair Traces - Yes / Trunk Hood, Rear Gate - Scratch & Dent - Large / (R) Rear Fender, Molding - Scratch & Dent - Small / (R) Rear Door, Molding - Scratch & Dent - Large / (R) Front Fender, Molding - Scratch - Small / (R) Front Door, Molding - Scratch - Small / (R) Mirror - Scratch - Small / Overall Exterior - Faded(Color, Gloss) - Yes / Front Bumper, Grille, Lamps - Scratch & Dent - Large / (L) Front Fender, Molding - Scratch - Small / (L) Mirror - Scratch - Small / (L) Front Door, Molding - Scratch - Small / (L) Center Panel - Scratch & Dent - Small / (L) Rear Fender, Molding - Scratch & Dent - Large / Rear Bumper, Lamps, Panels - Scratch & Dent - Large</p>
