General Information

Make	Toyota	Model	Hiace
YOM	2022	Odo Meter Reading	241,075
Registration No.	GAW4248	Chassis No.	JTFNAFAP0M8023522
CC	2.8	Transmission	M/T
Fuel Type	Diesel	Type of Body	Van
Colour	Black

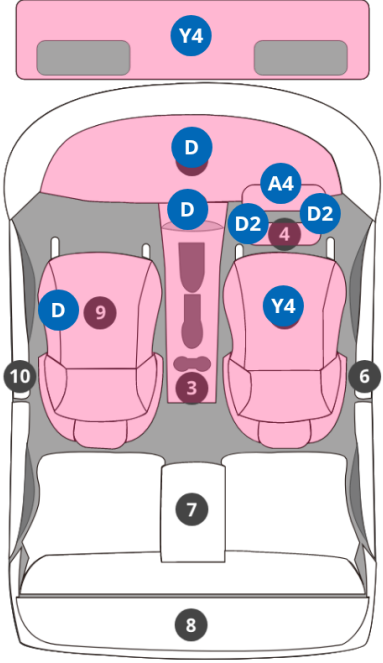
Interior Evaluation : C	Exterior Evaluation : E

<p>a : Cut, Fray d : Loose, Deformed k : Animal Hair s : Smell t : Cigarette Burns x : Defective y : Stain</p>

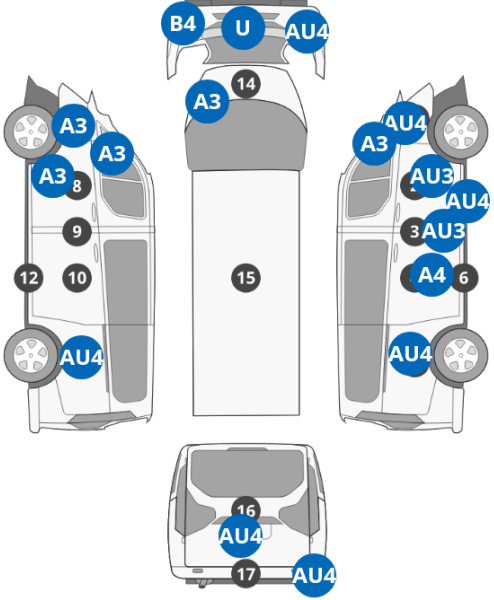
<p>A : Scratch AU : Scratch & Dent B : Modified C : Corrosion G : Stone chip P : Faded S : Rust SC : Rust & Corrosion U : Dent X : Defective Y : Crack, Gap</p>
<p>Remarks (R) Front Seat - Grime - Large / Console, Switches, Vents - Traces of Adhesive Tape - Yes / Dashboard - Traces of Adhesive Tape - Yes / Ceiling - Grime - Large / (L) Front Seat - Repair Mark - Yes / (L) Front Floor Mat - Worked - Small / (R) Front Floor Mat - Worked - Small / Overall Interior - Worn as per age - Yes / Steering Wheel - Worn, Peel, Crack - Large</p>	<p>Remarks (R) Front Door - Repair Traces - Yes / (R) Step - Repair Traces - Yes / (R) Front Fender - Repair Traces - Yes / Bonnet - Repair Traces - Yes / (R) Center Panel - Repair Traces - Yes / (L) Rear Fender, Molding - Scratch & Dent - Large / (L) Front Door, Molding - Scratch - Medium / (L) Front Fender, Molding - Scratch - Medium / (L) Mirror - Scratch - Medium / Front Bumper, Grille, Lamps - Modified - Large / Member (Bolted) - Dent - Yes / Bonnet, Headlight - Scratch - Medium / Front Bumper, Grille, Lamps - Scratch & Dent - Large / (R) Front Fender, Molding - Scratch & Dent - Large / (R) Mirror - Scratch - Medium / (R) Step, In-panel, Side Spoiler - Scratch & Dent - Large / (R) Front Door, Molding - Scratch & Dent - Medium / (R) Center Panel - Scratch & Dent - Medium / (R) Rear Door, Molding - Scratch - Large / (R) Rear Fender, Molding - Scratch & Dent - Large / Trunk Hood, Rear Gate - Scratch & Dent - Large / Rear Bumper, Lamps, Panels - Scratch & Dent - Large</p>

<p>Inspector Notes</p>
<p>Possible flooding. Battery for replacement. Engine oil for replacement. Driving belt unusual sound. Aircon issue. Brake pedal issue. Not advisable to drive the unit due of brakes and underchassis issue. Without warrantybooklet, jack, tools and sest cover. With spare tire but worn. 1 key. With LTO plate.</p>
