General Information

Make	Toyota	Model	Vios
YOM	2024	Odo Meter Reading	16,236
Registration No.	GBC2614	Chassis No.	PA1B18F39P4234828
CC	1.3	Transmission	CVT
Fuel Type	Gas	Type of Body	Sedan
Colour	Black

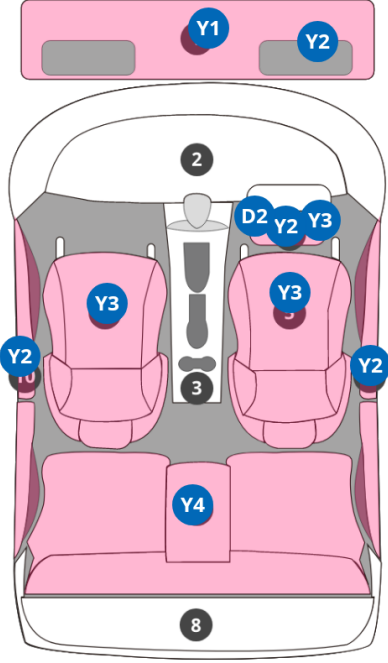
Interior Evaluation : C	Exterior Evaluation : E

<p>a : Cut, Fray d : Loose, Deformed k : Animal Hair s : Smell t : Cigarette Burns x : Defective y : Stain</p>

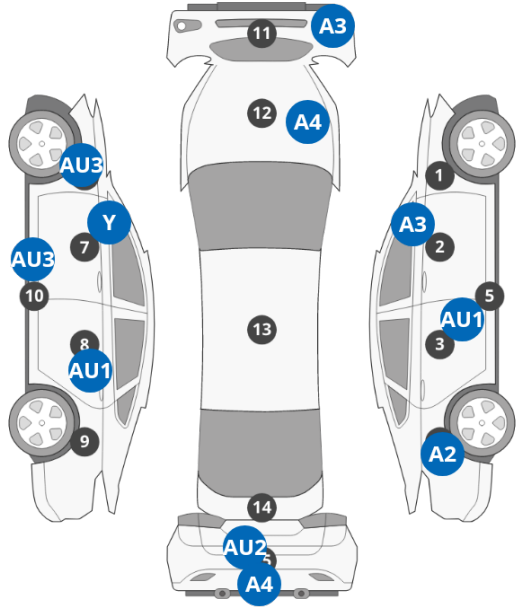
<p>A : Scratch AU : Scratch & Dent B : Modified C : Corrosion G : Stone chip P : Faded S : Rust SC : Rust & Corrosion U : Dent X : Defective Y : Crack, Gap</p>
<p>Remarks (R) Front Trim - Grime - Small / (R) Front Floor Mat - Grime - Medium / Sunvisor, Sunglass Holder - Grime - Small / (R) Front Seat - Grime - Medium / Rear Seat - Grime - Large / Mat Other - Grime - Small / Ceiling - Grime - Minimal / (L) Front Trim - Grime - Small / (L) Front Floor Mat - Worked - Small / (L) Front Seat - Grime - Medium</p>	<p>Remarks (L) Front Fender, Molding - Scratch & Dent - Medium / (L) Rear Door, Molding - Scratch & Dent - Minimal / (L) Mirror - Crack - Damaged / (L) Step, In-panel, Side Spoiler - Scratch & Dent - Medium / Trunk Hood, Rear Gate - Scratch & Dent - Small / Rear Bumper, Lamps, Panels - Scratch - Large / (R) Rear Fender, Molding - Scratch - Small / (R) Rear Door, Molding - Scratch & Dent - Minimal / (R) Mirror - Scratch - Medium / Bonnet, Headlight - Scratch - Large / Front Bumper, Grille, Lamps - Scratch - Medium</p>
