General Information

Make	Toyota	Model	Wigo
YOM	2019	Odo Meter Reading	98,145
Registration No.	EAC1305	Chassis No.	MHKA4D5FJJ024715
CC	1.0	Transmission	A/T
Fuel Type	Gas	Type of Body	Hatchback
Colour	Black

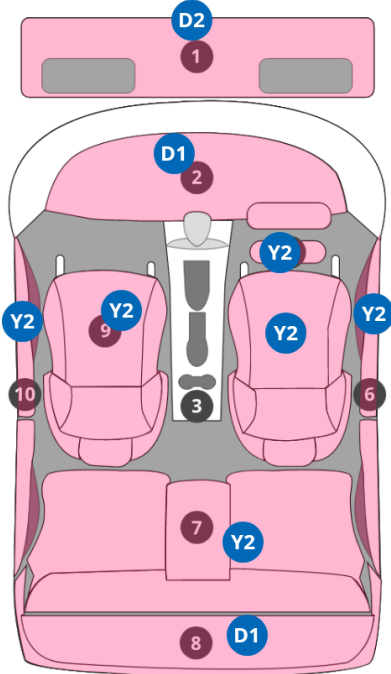
Interior Evaluation : B	Exterior Evaluation : E

<p>a : Cut, Fray d : Loose, Deformed k : Animal Hair s : Smell t : Cigarette Burns x : Defective y : Stain</p>

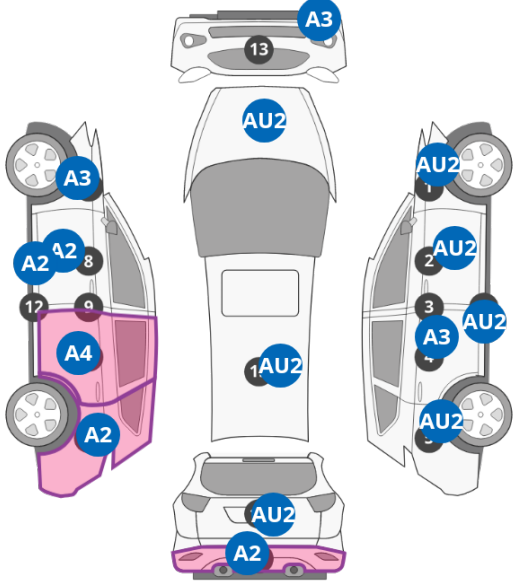
<p>A : Scratch AU : Scratch & Dent B : Modified C : Corrosion G : Stone chip P : Faded S : Rust SC : Rust & Corrosion U : Dent X : Defective Y : Crack, Gap</p>
Remarks (L) Front Floor Mat - Grime - Small / (L) Front Trim - Grime - Small / (R) Front Trim - Grime - Small / Dashboard - Worked - Minimal / Rear Seat - Grime - Small / (L) Front Seat - Grime - Small / (R) Front Seat - Grime - Small / Trunk Room - Worked - Minimal / Ceiling - Crinkle - Small	Remarks (R) Rear Door - Repair Traces - Yes / (L) Front Door, Molding - Scratch - Small / (L) Step, In-panel, Side Spoiler - Scratch - Small / (L) Rear Door, Molding - Repair mark - Yes / (L) Rear Door, Molding - Scratch - Large / (L) Rear Fender, Molding - Repair mark - Yes / (L) Rear Fender, Molding - Scratch - Small / Rear Bumper, Lamps, Panels - Repair mark - Yes / Rear Bumper, Lamps, Panels - Scratch - Small / Trunk Hood, Rear Gate - Scratch & Dent - Small / (R) Rear Fender, Molding - Scratch & Dent - Small / (R) Rear Door, Molding - Scratch - Medium / (R) Step, In-panel, Side Spoiler - Scratch & Dent - Small / (R) Front Door, Molding - Scratch & Dent - Small / (R) Front Fender, Molding - Scratch & Dent - Small / Roof - Scratch & Dent - Small / Bonnet, Headlight - Scratch & Dent - Small / Front Bumper, Grille, Lamps - Scratch - Medium / (L) Front Fender, Molding - Scratch - Medium
