General Information

Make	Mitsubishi	Model	Strada
YOM	2018	Odo Meter Reading	118,860
Registration No.	CA07970	Chassis No.	MMBJYKK10JH056318
CC	2.4	Transmission	A/T
Fuel Type	Diesel	Type of Body	Pickup
Colour	Pearl White

Body / Panel Condition

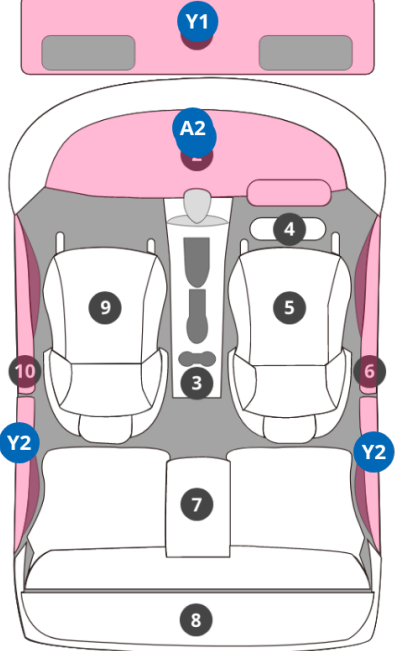
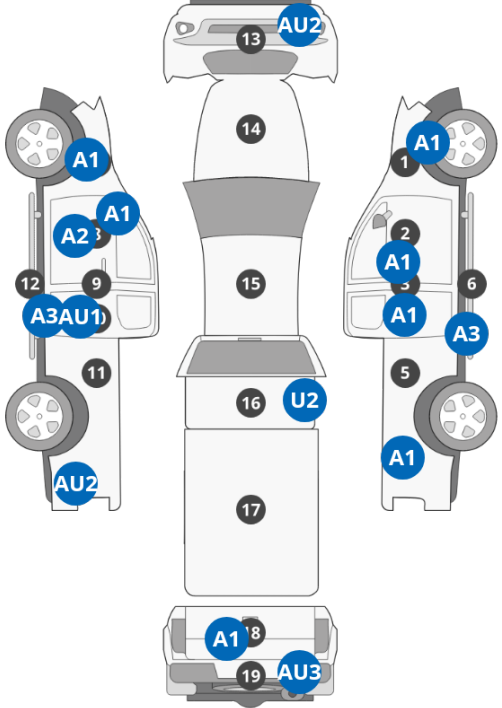
Interior Evaluation :	B	Exterior Evaluation :	C

<p>a : Cut, Fray d : Loose, Deformed k : Animal Hair s : Smell t : Cigarette Burns x : Defective y : Stain</p>		<p>A : Scratch AU : Scratch & Dent B : Modified C : Corrosion G : Stone chip P : Faded S : Rust SC : Rust & Corrosion U : Dent X : Defective Y : Crack, Gap</p>	
<p>Remarks Ceiling - Grime - Minimal / Dashboard - Traces of Adhesive Tape - Yes / Steering Wheel - Worn, Peel, Crack - Small / (R) Rear Trim - Grime - Small / (L) Rear Trim - Grime - Small</p>		<p>Remarks (R) Front Door - Repair Traces - Yes / Bonnet - Repair Traces - Yes / (R) Rear Door - Repair Traces - Yes / (R) Front Fender, Molding - Scratch - Minimal / (R) Front Door, Molding - Scratch - Minimal / (R) Rear Door, Molding - Scratch - Minimal / (R) Step, In-panel, Side Spoiler - Scratch - Medium / (R) Side Gate - Scratch - Minimal / Rear Bumper, Lamps, Panels - Scratch & Dent - Medium / Rear Gate - Scratch - Minimal / (L) Side Gate - Scratch & Dent - Small / (L) Step, In-panel, Side Spoiler - Scratch - Medium / (L) Rear Door, Molding - Scratch & Dent - Minimal / (L) Mirror - Scratch - Minimal / (L) Front Door, Molding - Scratch - Small / (L) Front Fender, Molding - Scratch - Minimal / Front Bumper, Grille, Lamps - Scratch & Dent - Small / Roof - Dent - Small</p>
