General Information

Make	Hyundai	Model	Elantra
YOM	2017	Odo Meter Reading	71,882
Registration No.	NCP4308-SELLER'S YARD	Chassis No.	KMHD741CBHU418847
CC	1.6	Transmission	A/T
Fuel Type	Gas	Type of Body	Sedan
Colour	Black

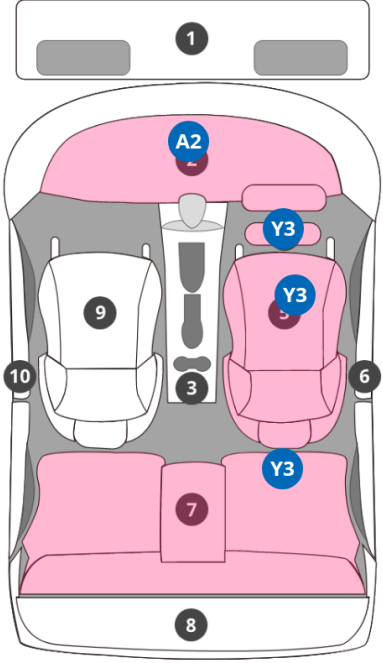
Interior Evaluation : B	Exterior Evaluation : E

<p>a : Cut, Fray d : Loose, Deformed k : Animal Hair s : Smell t : Cigarette Burns x : Defective y : Stain</p>

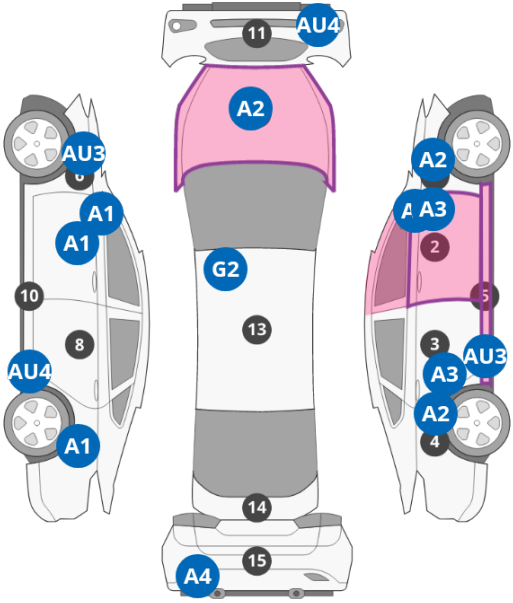
<p>A : Scratch AU : Scratch & Dent B : Modified C : Corrosion G : Stone chip P : Faded S : Rust SC : Rust & Corrosion U : Dent X : Defective Y : Crack, Gap</p>
<p>Remarks (R) Front Floor Mat - Grime - Medium / (R) Front Seat - Grime - Medium / Rear Seat - Grime - Medium / Steering Wheel - Worn, Peel, Crack - Small</p>	<p>Remarks (R) Front Door - Repair Traces - Yes / (R) Front Fender - Repair Traces - Yes / Bonnet - Repair Traces - Yes / (R) Front Fender, Molding - Scratch - Small / (R) Mirror - Scratch - Minimal / (R) Front Door, Molding - Repair mark - Yes / (R) Front Door, Molding - Scratch - Medium / (R) Step, In-panel, Side Spoiler - Scratch & Dent - Medium / (R) Step, In-panel, Side Spoiler - Repair mark - Yes / (R) Rear Fender, Molding - Scratch - Small / (R) Rear Door, Molding - Scratch - Medium / Rear Bumper, Lamps, Panels - Scratch - Large / (L) Step, In-panel, Side Spoiler - Scratch & Dent - Large / (L) Rear Fender, Molding - Scratch - Minimal / (L) Mirror - Scratch - Minimal / (L) Front Door, Molding - Scratch - Minimal / (L) Front Fender, Molding - Scratch & Dent - Medium / Front Bumper, Grille, Lamps - Scratch & Dent - Large / Bonnet, Headlight - Repair mark - Yes / Bonnet, Headlight - Scratch - Small / Front Windshield - Scratch, Stone chip - Small</p>

<p>Inspector Notes</p>
<p>With Lto plate, 1key, no warranty booklet, no spare tire, no jack and tools, scratches and cracked headlight and taillight,</p>
