General Information

Make	Mitsubishi	Model	Mirage
YOM	2023	Odo Meter Reading	40,400
Registration No.	NFP1356-SELLER'S YARD	Chassis No.	PAEA13TJPNA000846
CC	1.2	Transmission	A/T
Fuel Type	Gas	Type of Body	Sedan
Colour	Gray

Body / Panel Condition

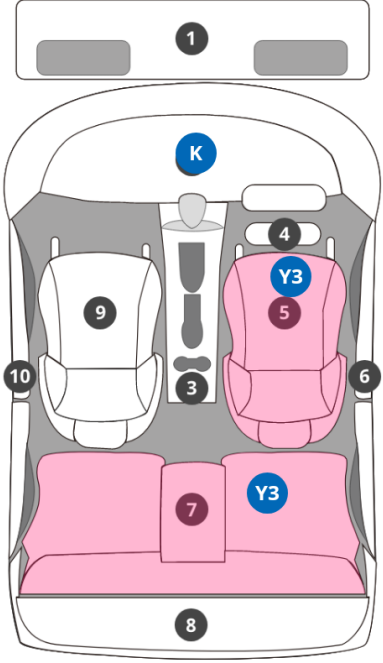
Interior Evaluation : B	Exterior Evaluation : C

<p>a : Cut, Fray d : Loose, Deformed k : Animal Hair s : Smell t : Cigarette Burns x : Defective y : Stain</p>

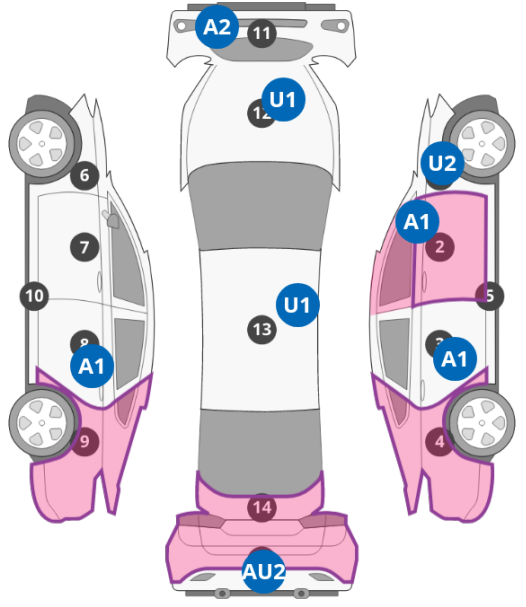
<p>A : Scratch AU : Scratch & Dent B : Modified C : Corrosion G : Stone chip P : Faded S : Rust SC : Rust & Corrosion U : Dent X : Defective Y : Crack, Gap</p>
<p>Remarks Overall Interior - Animal Hair - Yes / (R) Front Seat - Grime - Medium / Rear Seat - Grime - Medium</p>	<p>Remarks (L) Rear Fender - Repair Traces - Yes / (R) Rear Fender - Repair Traces - Yes / (R) Front Fender, Molding - Dent - Small / (R) Mirror - Scratch - Minimal / (R) Front Door, Molding - Repair mark - Difference in Color / (R) Rear Door, Molding - Scratch - Minimal / (R) Rear Fender, Molding - Repair mark - Yes / Rear Bumper, Lamps, Panels - Scratch & Dent - Small / (L) Rear Fender, Molding - Repair mark - Difference in Color / Trunk Hood, Rear Gate - Repair mark - Difference in Color / (L) Rear Door, Molding - Scratch - Minimal / Front Bumper, Grille, Lamps - Scratch - Small / Bonnet, Headlight - Dent - Minimal / Roof - Dent - Minimal</p>
