General Information

Make	Toyota	Model	Veloz
YOM	2024	Odo Meter Reading	15,516
Registration No.	CCF1174	Chassis No.	MHFAB1BY0R3095568
CC	1.5	Transmission	CVT
Fuel Type	Gas	Type of Body	SUV
Colour	Black

Body / Panel Condition

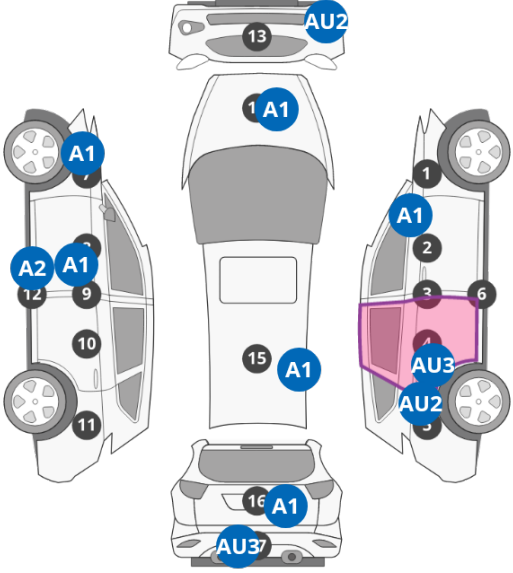
<p>A : Scratch AU : Scratch & Dent B : Modified C : Corrosion G : Stone chip P : Faded S : Rust SC : Rust & Corrosion U : Dent X : Defective Y : Crack, Gap</p>
Remarks Defects not found	Remarks (R) Rear Door - Repair Traces - Yes / (R) Rear Door, Molding - Repair mark - Yes / (R) Rear Door, Molding - Scratch & Dent - Medium / (R) Rear Fender, Molding - Scratch & Dent - Small / Rear Bumper, Lamps, Panels - Scratch & Dent - Medium / Trunk Hood, Rear Gate - Scratch - Minimal / (L) Step, In-panel, Side Spoiler - Scratch - Small / (L) Front Door, Molding - Scratch - Minimal / (L) Front Fender, Molding - Scratch - Minimal / Front Bumper, Grille, Lamps - Scratch & Dent - Small / (R) Mirror - Scratch - Minimal / Roof - Scratch - Minimal / Bonnet, Headlight - Scratch - Minimal

Inspector Notes
With Lto plate, with spare tire and jack, 1key, no warranty booklet, no tools,scratches on headlights and taillights
