General Information

Make	Toyota	Model	Vios
YOM	2024	Odo Meter Reading	4,629
Registration No.	NHM3791	Chassis No.	PA1B18F36P4238304
CC	1.3	Transmission	CVT
Fuel Type	Gas	Type of Body	Sedan
Colour	Black

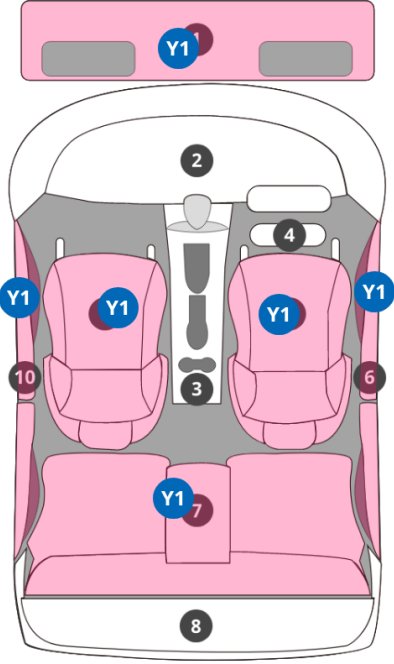
Interior Evaluation : A	Exterior Evaluation : D

<p>a : Cut, Fray d : Loose, Deformed k : Animal Hair s : Smell t : Cigarette Burns x : Defective y : Stain</p>

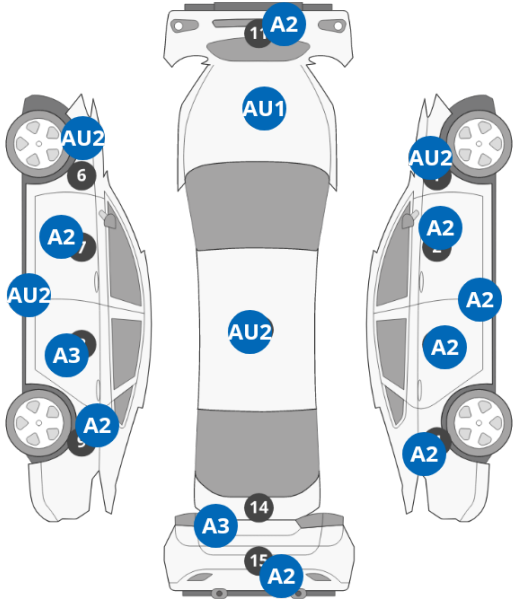
<p>A : Scratch AU : Scratch & Dent B : Modified C : Corrosion G : Stone chip P : Faded S : Rust SC : Rust & Corrosion U : Dent X : Defective Y : Crack, Gap</p>
<p>Remarks (L) Front Seat - Grime - Minimal / (R) Front Seat - Grime - Minimal / Rear Seat - Grime - Minimal / Ceiling - Grime - Minimal / (L) Front Trim - Grime - Minimal / (R) Front Trim - Grime - Minimal</p>	<p>Remarks Bonnet, Headlight - Scratch & Dent - Minimal / Front Bumper, Grille, Lamps - Scratch - Small / (R) Front Fender, Molding - Scratch & Dent - Small / (R) Front Door, Molding - Scratch - Small / (R) Rear Door, Molding - Scratch - Small / (R) Step, In-panel, Side Spoiler - Scratch - Small / (R) Rear Fender, Molding - Scratch - Small / Rear Bumper, Lamps, Panels - Scratch - Small / Trunk Hood, Rear Gate - Scratch - Medium / (L) Rear Fender, Molding - Scratch - Small / (L) Rear Door, Molding - Scratch - Medium / (L) Front Door, Molding - Scratch - Small / Roof - Scratch & Dent - Small / (L) Step, In-panel, Side Spoiler - Scratch & Dent - Small / (L) Front Fender, Molding - Scratch & Dent - Small</p>
