General Information

Make	Toyota	Model	Lite Ace
YOM	2024	Odo Meter Reading	29,606
Registration No.	NHM3636	Chassis No.	MHKU3FE10PK005681
CC	1.5	Transmission	M/T
Fuel Type	Gas	Type of Body	Utility Vehicle
Colour	White

Body / Panel Condition

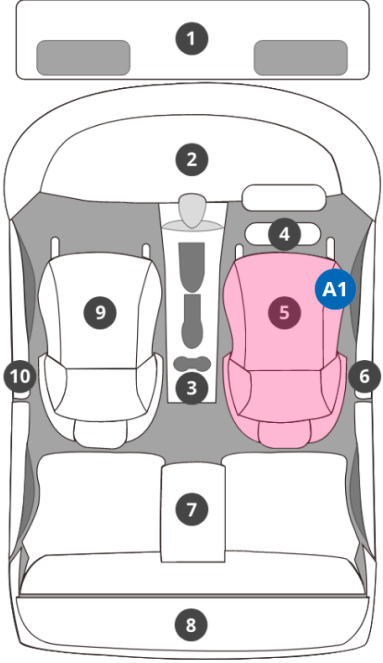
Interior Evaluation : A	Exterior Evaluation : C

<p>a : Cut, Fray d : Loose, Deformed k : Animal Hair s : Smell t : Cigarette Burns x : Defective y : Stain</p>

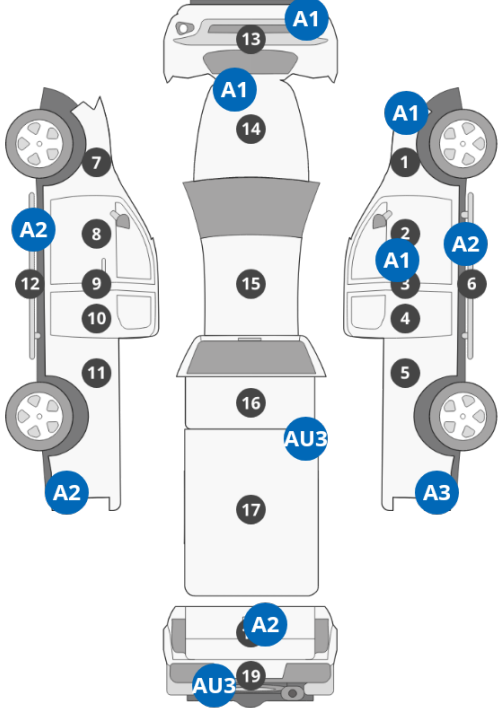
<p>A : Scratch AU : Scratch & Dent B : Modified C : Corrosion G : Stone chip P : Faded S : Rust SC : Rust & Corrosion U : Dent X : Defective Y : Crack, Gap</p>
Remarks (R) Front Seat - Cut, Crack - Minimal	Remarks (R) Front Fender, Molding - Scratch - Minimal / (R) Front Door, Molding - Scratch - Minimal / Roof - Scratch & Dent - Medium / (R) Side Gate - Scratch - Medium / Rear Gate - Scratch - Small / Rear Bumper, Lamps, Panels - Scratch & Dent - Medium / (L) Side Gate - Scratch - Small / (R) Step, In-panel, Side Spoiler - Scratch - Small / (L) Step, In-panel, Side Spoiler - Scratch - Small / Front Bumper, Grille, Lamps - Scratch - Minimal / Bonnet, Headlight - Scratch - Minimal
Frame Evaluation : A	Functional Evaluation : B
Remarks Defects not found	Remarks Battery - Weak - Yes / Reverse Camera - N/A - Yes / Spare Key - Issue - Unexist

Inspector Notes
With Lto plate, with spare tire, with jack and tools, 1key, no warranty booklet, scratches on headlights and taillights, battery weak
