General Information

Make	Toyota	Model	Wigo
YOM	2021	Odo Meter Reading	40,720
Registration No.	NEW9655	Chassis No.	MHKA4DF5FMJ056890
CC	1.0	Transmission	A/T
Fuel Type	Gas	Type of Body	Hatchback
Colour	Yellow

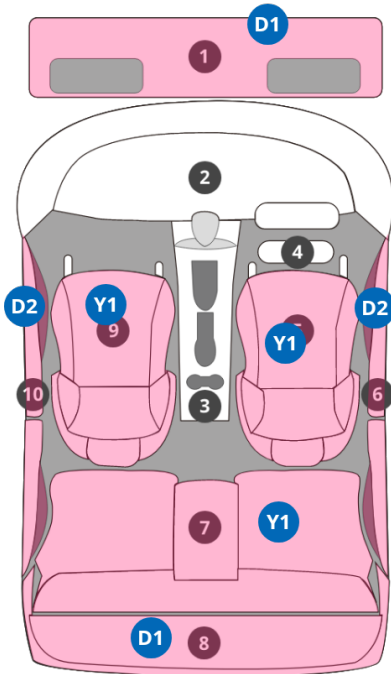
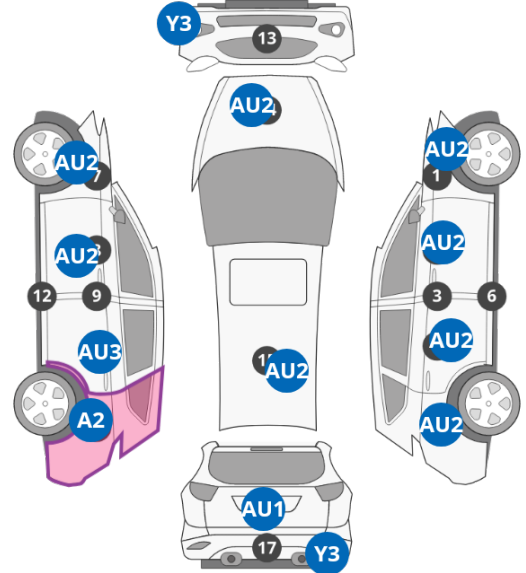
Interior Evaluation :	A	Exterior Evaluation :	D

<p>a : Cut, Fray d : Loose, Deformed k : Animal Hair s : Smell t : Cigarette Burns x : Defective y : Stain</p>		<p>A : Scratch AU : Scratch & Dent B : Modified C : Corrosion G : Stone chip P : Faded S : Rust SC : Rust & Corrosion U : Dent X : Defective Y : Crack, Gap</p>	
<p>Remarks (R) Front Trim - Worked - Small / (L) Front Trim - Worked - Small / (L) Front Seat - Grime - Minimal / (R) Front Seat - Grime - Minimal / Ceiling - Crinkle - Minimal / Rear Seat - Grime - Minimal / Trunk Room - Worked - Minimal</p>		<p>Remarks (L) Rear Fender - Repair Traces - Yes / (L) Front Door, Molding - Scratch & Dent - Small / (L) Rear Door, Molding - Scratch & Dent - Medium / (L) Rear Fender, Molding - Repair mark - Yes / (L) Rear Fender, Molding - Scratch - Small / Rear Bumper, Lamps, Panels - Crack, Gap - Medium / Roof - Scratch & Dent - Small / (R) Rear Door, Molding - Scratch & Dent - Small / (R) Front Door, Molding - Scratch & Dent - Small / (R) Front Fender, Molding - Scratch & Dent - Small / Front Bumper, Grille, Lamps - Crack, Gap - Medium / Bonnet, Headlight - Scratch & Dent - Small / (L) Front Fender, Molding - Scratch & Dent - Small / Trunk Hood, Rear Gate - Scratch & Dent - Minimal / (R) Rear Fender, Molding - Scratch & Dent - Small</p>

Frame Evaluation :	C	Functional Evaluation :	A
<p>Remarks Front Cross Member Support - Traces of Bending, or Marks of Panel Repair ? - Yes / Right Front Inside Panel (Front Side) - Traces of Bending, or Marks of Panel Repair ? - Yes</p>		<p>Remarks Lamps (Brake, Tail, Fog) - Issue - Yes / Horn - Issue - Yes / Spare Key - Issue - Unexist</p>
