General Information

Make	Toyota	Model	Vios
YOM	2024	Odo Meter Reading	19,898
Registration No.	DBN6217	Chassis No.	PA1B18F31P4231812
CC	1.3	Transmission	CVT
Fuel Type	Gas	Type of Body	Sedan
Colour	Green

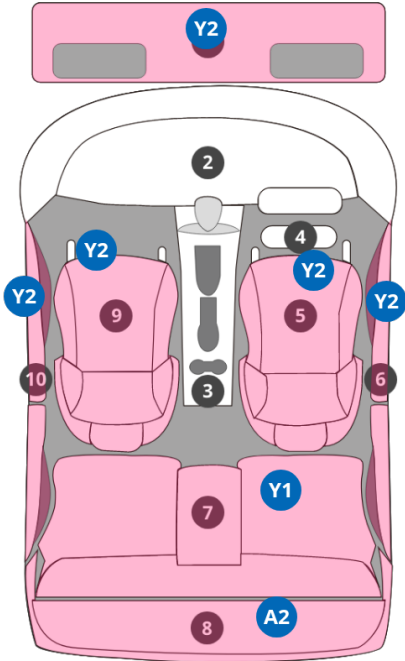
Interior Evaluation : B	Exterior Evaluation : C

<p>A : Scratch AU : Scratch & Dent B : Modified C : Corrosion G : Stone chip P : Faded S : Rust SC : Rust & Corrosion U : Dent X : Defective Y : Crack, Gap</p>
<p>Remarks Rear Seat - Grime - Minimal / Ceiling - Grime - Small / (L) Front Trim - Grime - Small / (R) Front Trim - Grime - Small / (L) Front Seat - Grime - Small / (R) Front Seat - Grime - Small / Trunk Room - Worn, Scratch, Cut, Crack - Small</p>	<p>Remarks (L) Front Door - Repair Traces - Yes / (R) Front Door, Molding - Scratch - Small / (R) Front Fender, Molding - Scratch - Small / (R) Rear Door, Molding - Scratch - Medium / (R) Rear Fender, Molding - Scratch & Dent - Small / Trunk Hood, Rear Gate - Scratch & Dent - Small / Rear Bumper, Lamps, Panels - Scratch - Small / (L) Rear Fender, Molding - Scratch - Medium / (L) Rear Door, Molding - Scratch - Small / (L) Front Door, Molding - Scratch - Medium / (L) Front Fender, Molding - Scratch & Dent - Minimal / Bonnet, Headlight - Scratch & Dent - Minimal / Front Bumper, Grille, Lamps - Scratch & Dent - Minimal / Roof - Scratch & Dent - Small</p>

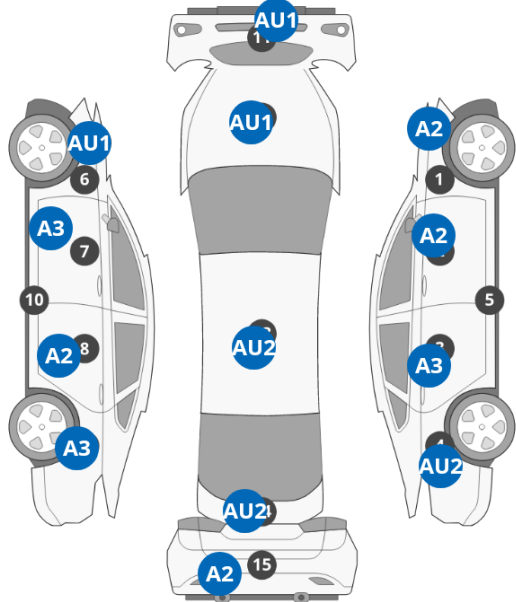
<p>Inspector Notes</p>
<p>with LTO plate, with spare tire, with inc tools & jack, with manual and warranty booklet, no reverse camera, scratches on taillight, unusual under the trunk.</p>
