General Information

Make	Toyota	Model	Vios
YOM	2022	Odo Meter Reading	54,091
Registration No.	NID1395	Chassis No.	PA1B18F35N4184443
CC	1.3	Transmission	CVT
Fuel Type	Gas	Type of Body	Sedan
Colour	Red Mica Metallic

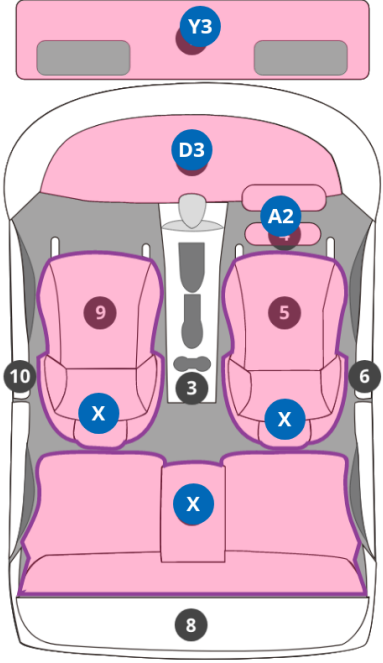
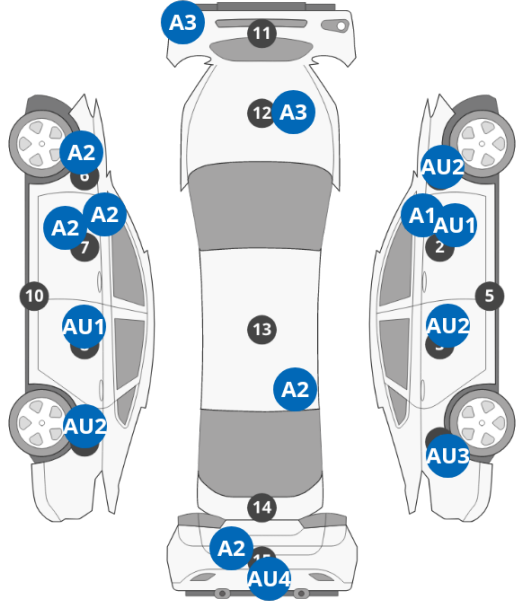
Interior Evaluation :	B	Exterior Evaluation :	D

<p>a : Cut, Fray d : Loose, Deformed k : Animal Hair s : Smell t : Cigarette Burns x : Defective y : Stain</p>		<p>A : Scratch AU : Scratch & Dent B : Modified C : Corrosion G : Stone chip P : Faded S : Rust SC : Rust & Corrosion U : Dent X : Defective Y : Crack, Gap</p>	
<p>Remarks Ceiling - Grime - Medium / Dashboard - Loose, Deformed - Medium / (L) Front Floor Mat - Cut, Crack - Small / (R) Front Seat Head Rest - Missing - Yes / Rear Seat Head Rest - Missing - Yes / (L) Front Seat Head Rest - Missing - Yes</p>		<p>Remarks (L) Front Door - Repair Traces - Yes / (L) Rear Door - Repair Traces - Yes / (R) Front Fender, Molding - Scratch & Dent - Small / (R) Mirror - Scratch - Minimal / (R) Front Door, Molding - Scratch & Dent - Minimal / (R) Rear Door, Molding - Scratch & Dent - Small / (R) Rear Fender, Molding - Scratch & Dent - Medium / Rear Bumper, Lamps, Panels - Scratch & Dent - Large / Trunk Hood, Rear Gate - Scratch - Small / (L) Rear Fender, Molding - Scratch & Dent - Small / (L) Rear Door, Molding - Scratch & Dent - Minimal / (L) Front Door, Molding - Scratch - Small / (L) Mirror - Scratch - Small / (L) Front Fender, Molding - Scratch - Small / Bonnet, Headlight - Scratch - Medium / Front Bumper, Grille, Lamps - Scratch - Medium / Roof - Scratch - Small</p>
