General Information

Make	Toyota	Model	Avanza
YOM	2024	Odo Meter Reading	22,426
Registration No.	NHM3733	Chassis No.	MHFAB1Y9P3072173
CC	1.5	Transmission	CVT
Fuel Type	Gas	Type of Body	Sedan
Colour	Silver

Body / Panel Condition

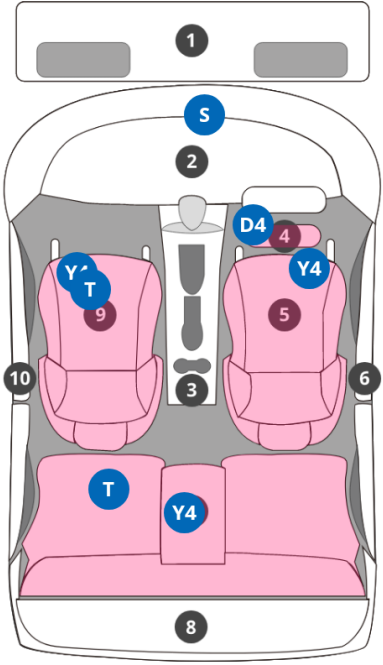
Interior Evaluation : D	Exterior Evaluation : E

<p>a : Cut, Fray d : Loose, Deformed k : Animal Hair s : Smell t : Cigarette Burns x : Defective y : Stain</p>

<p>A : Scratch AU : Scratch & Dent B : Modified C : Corrosion G : Stone chip P : Faded S : Rust SC : Rust & Corrosion U : Dent X : Defective Y : Crack, Gap</p>
<p>Remarks (L) Front Seat - Grime - Large / (L) Front Seat - Cigarette Burns - Burnt, Hole / Overall Interior - Smell - Yes / (R) Front Seat - Grime - Large / Rear Seat - Grime - Large / Rear Seat - Cigarette Burns - Burnt, Hole / (L) Front Floor Mat - Worked - Large</p>	<p>Remarks Front Bumper, Grille, Lamps - Scratch & Dent - Large / (R) Front Fender, Molding - Scratch & Dent - Large / (R) Front Door, Molding - Scratch & Dent - Large / (R) Rear Door, Molding - Scratch & Dent - Large / (R) Rear Fender, Molding - Scratch & Dent - Large / Rear Bumper, Lamps, Panels - Scratch & Dent - Large / (L) Rear Fender, Molding - Crack, Gap - Large / (L) Rear Door, Molding - Scratch & Dent - Large / (L) Front Door, Molding - Scratch - Medium / (L) Front Fender, Molding - Scratch - Medium / Bonnet, Headlight - Dent - Small / Trunk Hood, Rear Gate - Scratch - Small</p>
