General Information

Make	Toyota	Model	Avanza
YOM	2024	Odo Meter Reading	69,578
Registration No.	FAR9886	Chassis No.	MHFAA1BY2R0026661
CC	1.3	Transmission	M/T
Fuel Type	Gas	Type of Body	MPV
Colour	White

Body / Panel Condition

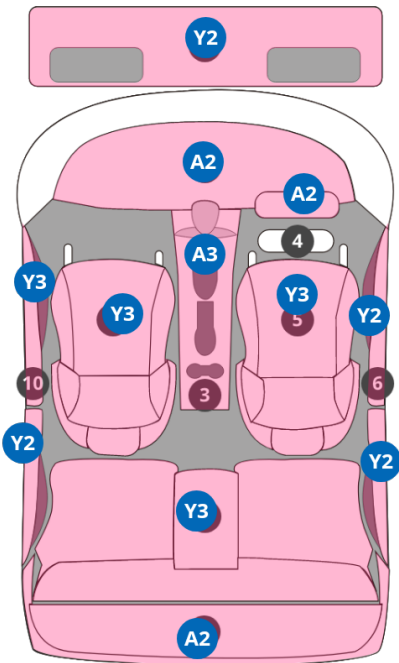
Interior Evaluation : D	Exterior Evaluation : E

<p>a : Cut, Fray d : Loose, Deformed k : Animal Hair s : Smell t : Cigarette Burns x : Defective y : Stain</p>

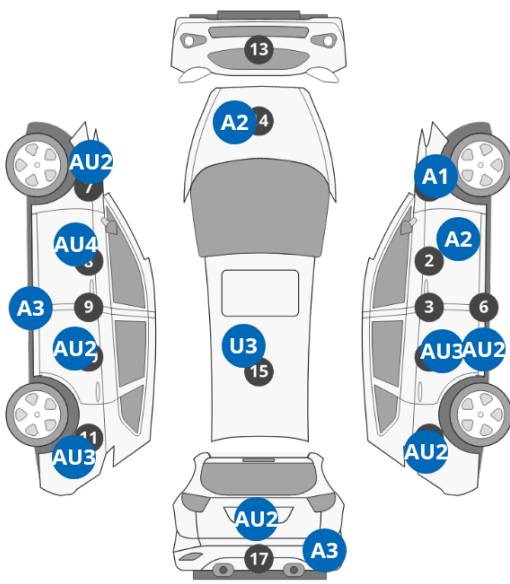
<p>A : Scratch AU : Scratch & Dent B : Modified C : Corrosion G : Stone chip P : Faded S : Rust SC : Rust & Corrosion U : Dent X : Defective Y : Crack, Gap</p>
<p>Remarks (L) Front Trim - Grime - Medium / (L) Front Seat - Grime - Medium / Steering Wheel - Worn, Peel, Crack - Small / Dashboard - Worn, Scratch, Cut, Crack - Small / Ceiling - Grime - Small / (L) Rear Trim - Grime - Small / Rear Seat - Grime - Medium / Trunk Room - Worn, Scratch, Cut, Crack - Small / (R) Front Seat - Grime - Medium / (R) Front Trim - Grime - Small / (R) Rear Trim - Grime - Small / Console, Switches, Vents - Worn, Scratch, Cut, Crack - Medium</p>	<p>Remarks (L) Front Door, Molding - Scratch & Dent - Large / (L) Front Fender, Molding - Scratch & Dent - Small / (L) Rear Door, Molding - Scratch & Dent - Small / (L) Rear Fender, Molding - Scratch & Dent - Medium / Trunk Hood, Rear Gate - Scratch & Dent - Small / Rear Bumper, Lamps, Panels - Scratch - Medium / (R) Rear Fender, Molding - Scratch & Dent - Small / (R) Rear Door, Molding - Scratch & Dent - Medium / (R) Step, In-panel, Side Spoiler - Scratch & Dent - Small / (R) Front Door, Molding - Scratch - Small / (R) Front Fender, Molding - Scratch - Minimal / Bonnet, Headlight - Scratch - Small / Front Bumper, Grille, Lamps - Scratch - Medium / Roof - Dent - Medium / (L) Step, In-panel, Side Spoiler - Scratch - Medium</p>
