## General Information

<b>Make</b>	Toyota	<b>Model</b>	Vios
<b>YOM</b>	2025	<b>Odo Meter Reading</b>	19,334
<b>Registration No.</b>	GBJ6587	<b>Chassis No.</b>	PA1B18F3XS4287238
<b>CC</b>	1.3	<b>Transmission</b>	CVT
<b>Fuel Type</b>	Gas	<b>Type of Body</b>	Sedan
<b>Colour</b>	Blue

## Body / Panel Condition

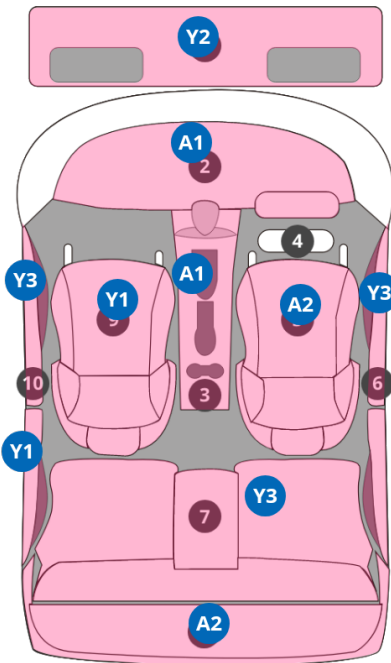
<b>Interior Evaluation :</b> <span style="float: right; color: red; font-weight: bold;">C</span>	<b>Exterior Evaluation :</b> <span style="float: right; color: red; font-weight: bold;">B</span>

<p><b>a</b> : Cut, Fray <b>d</b> : Loose, Deformed <b>k</b> : Animal Hair <b>s</b> : Smell <b>t</b> : Cigarette Burns <b>x</b> : Defective <b>y</b> : Stain</p>

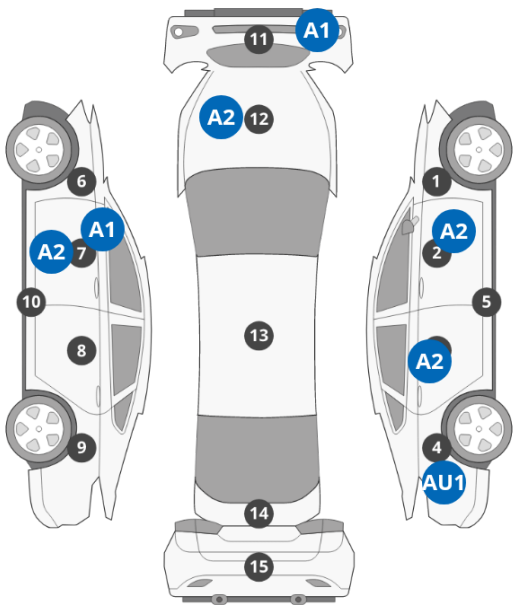
<p><b>A</b> : Scratch <b>AU</b> : Scratch &amp; Dent <b>B</b> : Modified <b>C</b> : Corrosion <b>G</b> : Stone chip <b>P</b> : Faded <b>S</b> : Rust <b>SC</b> : Rust &amp; Corrosion <b>U</b> : Dent <b>X</b> : Defective <b>Y</b> : Crack, Gap</p>
<p><b>Remarks</b> (R) Front Seat - Cut, Crack - Small / (R) Front Trim - Grime - Medium / Trunk Room - Worn, Scratch, Cut, Crack - Small / Rear Seat - Grime - Medium / (L) Rear Trim - Grime - Minimal / (L) Front Trim - Grime - Medium / (L) Front Seat - Grime - Minimal / Ceiling - Grime - Small / Console, Switches, Vents - Worn, Scratch, Cut, Crack - Minimal / Dashboard - Worn, Scratch, Cut, Crack - Minimal</p>	<p><b>Remarks</b> (L) Mirror - Scratch - Minimal / (L) Front Door, Molding - Scratch - Small / (R) Rear Fender, Molding - Scratch &amp; Dent - Minimal / (R) Rear Door, Molding - Scratch - Small / (R) Front Door, Molding - Scratch - Small / Front Bumper, Grille, Lamps - Scratch - Minimal / Bonnet, Headlight - Scratch - Small</p>
