General Information

Make	Toyota	Model	Vios
YOM	2024	Odo Meter Reading	7,068
Registration No.	DBO1943	Chassis No.	PA1B18F37P4237825
CC	1.3	Transmission	CVT
Fuel Type	Gas	Type of Body	Sedan
Colour	Red Mica Metallic

Body / Panel Condition

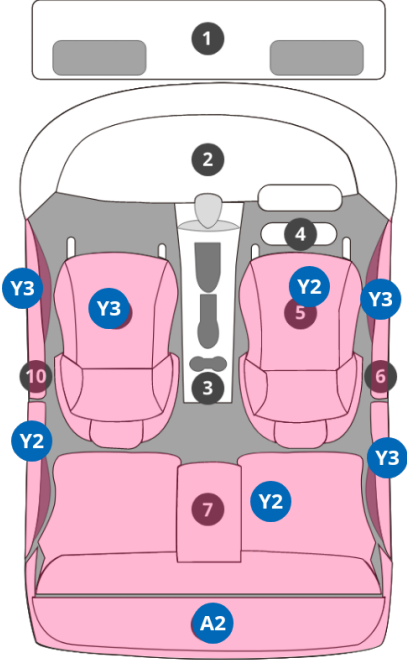
Interior Evaluation : C	Exterior Evaluation : B

<p>a : Cut, Fray d : Loose, Deformed k : Animal Hair s : Smell t : Cigarette Burns x : Defective y : Stain</p>

<p>A : Scratch AU : Scratch & Dent B : Modified C : Corrosion G : Stone chip P : Faded S : Rust SC : Rust & Corrosion U : Dent X : Defective Y : Crack, Gap</p>
<p>Remarks (R) Front Seat - Grime - Small / (R) Front Trim - Grime - Medium / (R) Rear Trim - Grime - Medium / Rear Seat - Grime - Small / Trunk Room - Worn, Scratch, Cut, Crack - Small / (L) Rear Trim - Grime - Small / (L) Front Trim - Grime - Medium / (L) Front Seat - Grime - Medium</p>	<p>Remarks Roof - Scratch - Small / (L) Front Fender, Molding - Scratch - Minimal / (L) Front Door, Molding - Scratch - Small / (L) Rear Door, Molding - Scratch - Small / Trunk Hood, Rear Gate - Scratch - Minimal / (L) Rear Fender, Molding - Scratch - Minimal / Rear Bumper, Lamps, Panels - Scratch - Small / (R) Rear Fender, Molding - Scratch - Minimal / (R) Rear Door, Molding - Scratch - Minimal / (R) Front Door, Molding - Scratch - Small / (R) Step, In-panel, Side Spoiler - Scratch - Minimal / (R) Front Fender, Molding - Scratch - Minimal / Bonnet, Headlight - Scratch - Small / Front Bumper, Grille, Lamps - Scratch - Minimal</p>
