General Information

Make	Ford	Model	Everest
YOM	2018	Odo Meter Reading	72,017
Registration No.	NBK2622	Chassis No.	MNCAXXMAWAHD57512
CC	3.2	Transmission	A/T
Fuel Type	Diesel	Type of Body	Sport Utility
Colour	Black

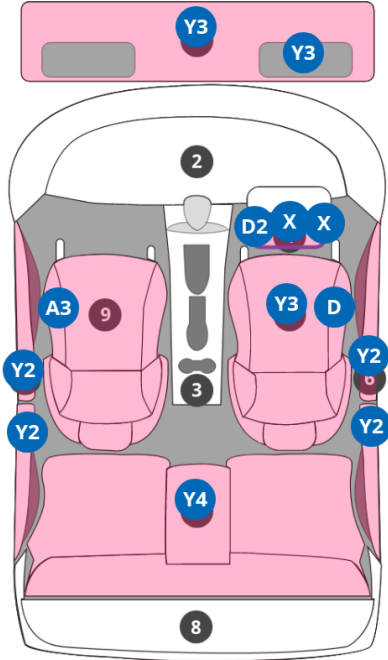
<p>a : Cut, Fray d : Loose, Deformed k : Animal Hair s : Smell t : Cigarette Burns x : Defective y : Stain</p>

<p>A : Scratch AU : Scratch & Dent B : Modified C : Corrosion G : Stone chip P : Faded S : Rust SC : Rust & Corrosion U : Dent X : Defective Y : Crack, Gap</p>
<p>Remarks (L) Front Seat - Cut, Crack - Medium / (L) Front Trim - Grime - Small / Mat Other - Missing - Yes / (L) Front Floor Mat - Worked - Small / (L) Rear Trim - Grime - Small / (R) Rear Trim - Grime - Small / Rear Seat - Grime - Large / Ceiling - Grime - Medium / (R) Front Trim - Grime - Small / (R) Front Floor Mat - Missing - Yes / (R) Front Seat - Repair Mark - Yes / (R) Front Seat - Grime - Medium / Sunvisor, Sunglass Holder - Grime - Medium</p>	<p>Remarks (R) Front Door - Repair Traces - Yes / (R) Step - Repair Traces - Yes / (R) Front Fender - Repair Traces - Yes / Bonnet - Repair Traces - Yes / (L) Front Fender - Repair Traces - Yes / (L) Rear Door - Repair Traces - Yes / (L) Front Fender, Molding - Scratch - Large / (L) Mirror - Scratch - Medium / (L) Front Door, Molding - Scratch - Medium / (L) Rear Door, Molding - Scratch - Small / (L) Step, In-panel, Side Spoiler - Scratch - Small / (L) Rear Fender, Molding - Scratch - Small / (R) Rear Fender, Molding - Scratch - Small / Rear Bumper, Lamps, Panels - Scratch - Medium / Trunk Hood, Rear Gate - Scratch - Small / (R) Rear Door, Molding - Scratch - Medium / (R) Mirror - Scratch - Medium / (R) Front Door, Molding - Scratch - Medium / (R) Front Fender, Molding - Scratch - Medium / Overall Exterior - Faded(Color, Gloss) - Yes / Bonnet, Headlight - Scratch - Medium / Front Bumper, Grille, Lamps - Scratch - Large / Roof - Scratch - Large</p>
