General Information

Make	Toyota	Model	Hiace
YOM	2022	Odo Meter Reading	262,767
Registration No.	GAW4123-1	Chassis No.	JTFNAFAP9M8022868
CC	2.8	Transmission	M/T
Fuel Type	Diesel	Type of Body	Van
Colour	Black

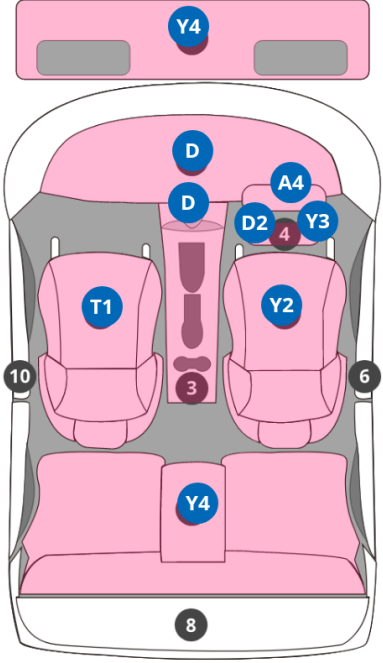
Interior Evaluation : D	Exterior Evaluation : E

<p>a : Cut, Fray d : Loose, Deformed k : Animal Hair s : Smell t : Cigarette Burns x : Defective y : Stain</p>

<p>A : Scratch AU : Scratch & Dent B : Modified C : Corrosion G : Stone chip P : Faded S : Rust SC : Rust & Corrosion U : Dent X : Defective Y : Crack, Gap</p>
<p>Remarks Ceiling - Grime - Large / Dashboard - Traces of Adhesive Tape - Yes / Console, Switchs, Vents - Traces of Adhesive Tape - Yes / Steering Wheel - Worn, Peel, Crack - Large / (R) Front Floor Mat - Grime - Medium / (L) Front Floor Mat - Worked - Small / (R) Front Seat - Grime - Small / Rear Seat - Grime - Large / (L) Front Seat - Cigarette Burns - Burnt Minimal</p>	<p>Remarks Front Bumper, Grille, Lamps - Scratch & Dent - Large / (L) Front Fender, Molding - Scratch & Dent - Medium / (L) Mirror - Scratch - Small / (L) Front Door, Molding - Scratch & Dent - Small / (L) Step, In-panel, Side Spoiler - Scratch & Dent - Large / (L) Center Panel - Scratch - Small / (L) Rear Fender, Molding - Scratch & Dent - Small / Trunk Hood, Rear Gate - Scratch & Dent - Large / Rear Bumper, Lamps, Panels - Scratch & Dent - Large / (R) Rear Fender, Molding - Scratch - Medium / (R) Rear Door, Molding - Scratch - Small / (R) Center Panel - Scratch - Small / (R) Front Door, Molding - Scratch & Dent - Small / (R) Front Fender, Molding - Scratch - Medium / (R) Mirror - Scratch - Small / Bonnet, Headlight - Repair mark - Yes / Overall Exterior - Faded(Color, Gloss) - Yes / Trunk Hood, Rear Gate - Repair mark - Yes</p>

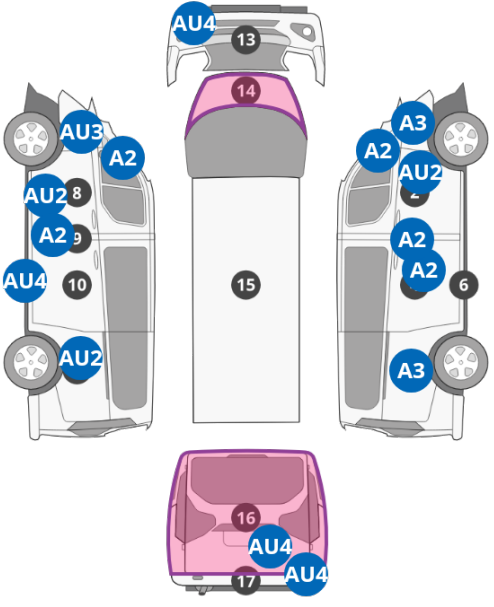
Possible flooding. Battery for replacement. Engine oil for replacement. Crack left tail light. Gap at front bumper. With warranty booklet, and spare tire. Without jack, tools and seat cover. 1 key. With LTO plate.
