General Information

Make	Toyota	Model	Innova
YOM	2023	Odo Meter Reading	53,721
Registration No.	NHJ6019	Chassis No.	PENDING
CC	2.8	Transmission	A/T
Fuel Type	Diesel	Type of Body	Wagon
Colour	Black

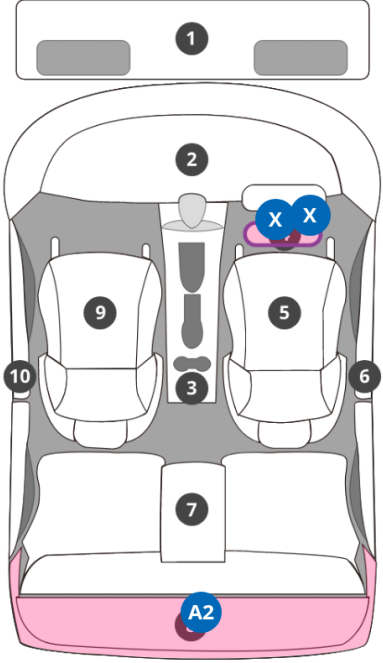
<p>a : Cut, Fray d : Loose, Deformed k : Animal Hair s : Smell t : Cigarette Burns x : Defective y : Stain</p>

<p>A : Scratch AU : Scratch & Dent B : Modified C : Corrosion G : Stone chip P : Faded S : Rust SC : Rust & Corrosion U : Dent X : Defective Y : Crack, Gap</p>
<p>Remarks (L) Front Floor Mat - Missing - Yes / Mat Other - Missing - Yes / Trunk Room - Worn, Scratch, Cut, Crack - Small</p>	<p>Remarks (R) Front Fender, Molding - Scratch - Medium / (R) Mirror - Scratch - Minimal / (R) Front Door, Molding - Scratch & Dent - Small / (R) Rear Door, Molding - Scratch - Large / (R) Rear Fender, Molding - Scratch - Medium / Rear Bumper, Lamps, Panels - Scratch & Dent - Large / (L) Rear Fender, Molding - Scratch & Dent - Minimal / (L) Front Door, Molding - Scratch - Minimal / Front Bumper, Grille, Lamps - Crack, Gap - Large / Bonnet, Headlight - Scratch - Minimal / Trunk Hood, Rear Gate - Scratch & Dent - Medium</p>
