General Information

Make	Toyota	Model	Hilux
YOM	2021	Odo Meter Reading	249,879
Registration No.	DAY1611	Chassis No.	MR0JB8DDL3174333
CC	2.4	Transmission	A/T
Fuel Type	Diesel	Type of Body	Pickup
Colour	Red

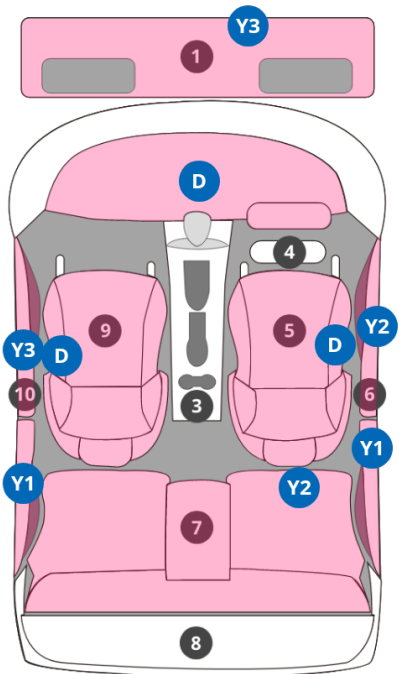
Interior Evaluation : C	Exterior Evaluation : E

<p>a : Cut, Fray d : Loose, Deformed k : Animal Hair s : Smell t : Cigarette Burns x : Defective y : Stain</p>

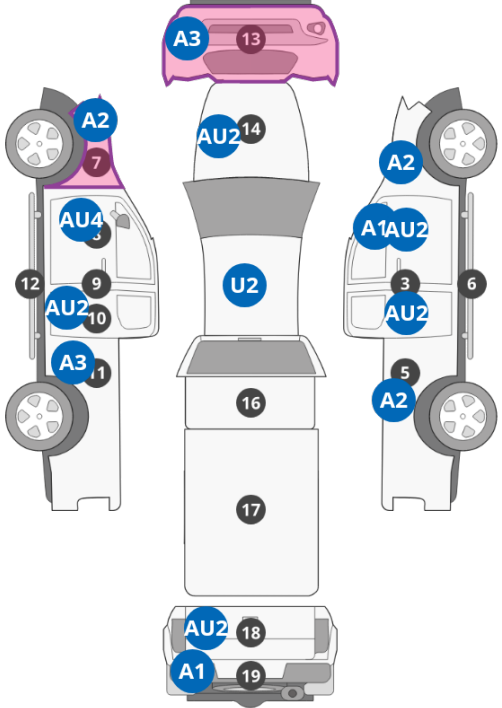
<p>A : Scratch AU : Scratch & Dent B : Modified C : Corrosion G : Stone chip P : Faded S : Rust SC : Rust & Corrosion U : Dent X : Defective Y : Crack, Gap</p>
<p>Remarks Dashboard - Traces of Adhesive Tape - Yes / Overall Interior - Worn as per age - Yes / (L) Front Seat - Worn - Yes / Ceiling - Grime - Medium / (R) Front Seat - Worn - Yes / (R) Front Trim - Grime - Small / (L) Front Trim - Grime - Medium / (R) Rear Trim - Grime - Minimal / (L) Rear Trim - Grime - Minimal / Rear Seat - Grime - Small</p>	<p>Remarks (R) Front Fender, Molding - Scratch - Small / (R) Mirror - Crack - Cracks / (R) Mirror - Scratch - Minimal / (R) Side Gate - Scratch - Small / (R) Front Door, Molding - Scratch & Dent - Small / (R) Rear Door, Molding - Scratch & Dent - Small / Rear Bumper, Lamps, Panels - Scratch - Minimal / Overall Exterior - Worn as per age - Yes / Rear Gate - Scratch & Dent - Small / (L) Side Gate - Scratch - Medium / (L) Front Door, Molding - Scratch & Dent - Large / (L) Rear Door, Molding - Scratch & Dent - Small / (L) Front Fender, Molding - Repair mark - Yes / (L) Front Fender, Molding - Scratch - Small / Front Bumper, Grille, Lamps - Repair mark - Yes / Front Bumper, Grille, Lamps - Scratch - Medium / Bonnet, Headlight - Scratch & Dent - Small / Roof - Dent - Small</p>
