General Information

Make	Toyota	Model	Rush
YOM	2021	Odo Meter Reading	37,716
Registration No.	DAU9083	Chassis No.	MHKE8FF3PLK030931
CC	1.5	Transmission	A/T
Fuel Type	Gas	Type of Body	SUV
Colour	Red

Body / Panel Condition

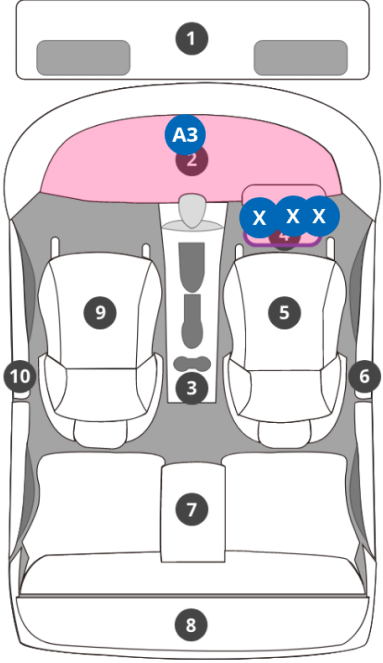
Interior Evaluation : B	Exterior Evaluation : C

<p>a : Cut, Fray d : Loose, Deformed k : Animal Hair s : Smell t : Cigarette Burns x : Defective y : Stain</p>

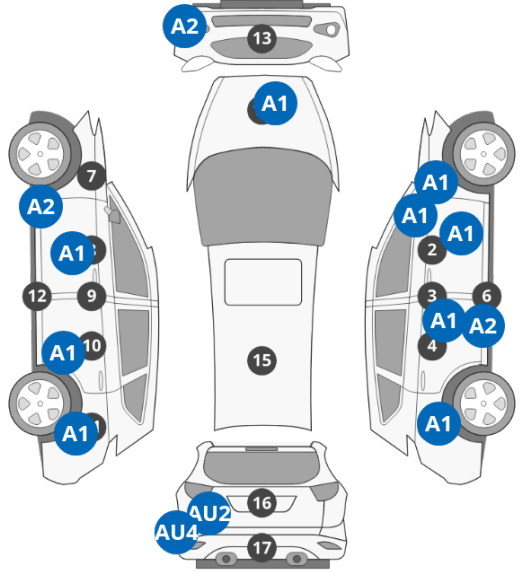
<p>A : Scratch AU : Scratch & Dent B : Modified C : Corrosion G : Stone chip P : Faded S : Rust SC : Rust & Corrosion U : Dent X : Defective Y : Crack, Gap</p>
<p>Remarks (R) Front Floor Mat - Missing - Yes / (L) Front Floor Mat - Missing - Yes / Mat Other - Missing - Yes / Steering Wheel - Worn, Peel, Crack - Medium</p>	<p>Remarks (R) Front Fender, Molding - Scratch - Minimal / (R) Mirror - Scratch - Minimal / (R) Front Door, Molding - Scratch - Minimal / (R) Step, In-panel, Side Spoiler - Scratch - Small / (R) Rear Door, Molding - Scratch - Minimal / (R) Rear Fender, Molding - Scratch - Minimal / Trunk Hood, Rear Gate - Scratch & Dent - Small / Rear Bumper, Lamps, Panels - Scratch & Dent - Large / (L) Rear Fender, Molding - Scratch - Minimal / (L) Rear Door, Molding - Scratch - Minimal / (L) Front Door, Molding - Scratch - Minimal / (L) Step, In-panel, Side Spoiler - Scratch - Small / Front Bumper, Grille, Lamps - Scratch - Small / Bonnet, Headlight - Scratch - Minimal</p>
