General Information

Make	Toyota	Model	Vios
YOM	2011	Odo Meter Reading	177,541
Registration No.	PQM857	Chassis No.	NCP920374092
CC	1.3	Transmission	M/T
Fuel Type	Gas	Type of Body	Sedan
Colour	Beige

Body / Panel Condition

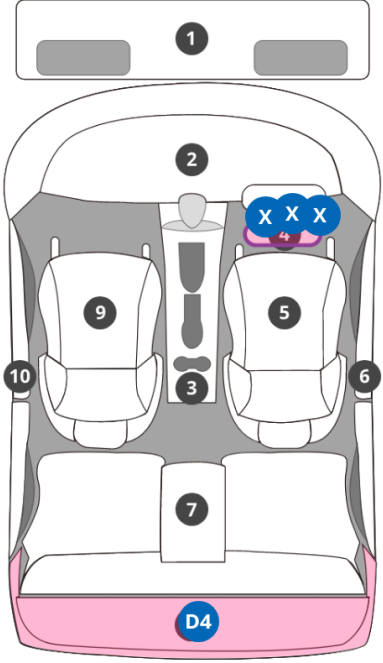
Interior Evaluation : C	Exterior Evaluation : D

<p>a : Cut, Fray d : Loose, Deformed k : Animal Hair s : Smell t : Cigarette Burns x : Defective y : Stain</p>

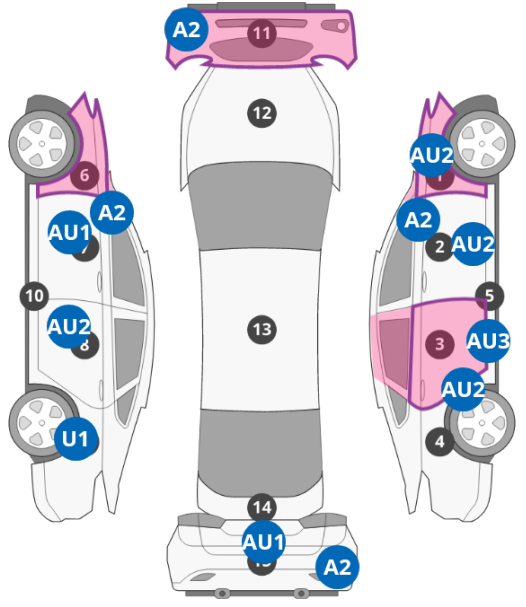
<p>A : Scratch AU : Scratch & Dent B : Modified C : Corrosion G : Stone chip P : Faded S : Rust SC : Rust & Corrosion U : Dent X : Defective Y : Crack, Gap</p>
Remarks (R) Front Floor Mat - Missing - Yes / (L) Front Floor Mat - Missing - Yes / Mat Other - Missing - Yes / Trunk Room - Loose, Deformed - Large	Remarks (R) Front Fender - Repair Traces - Yes / (L) Front Fender - Repair Traces - Yes / (R) Rear Door - Repair Traces - Yes / (R) Front Fender, Molding - Repair mark - Yes / (R) Mirror - Scratch - Small / (R) Front Door, Molding - Scratch & Dent - Small / (R) Rear Door, Molding - Repair mark - Difference in Color / (R) Step, In-panel, Side Spoiler - Scratch & Dent - Medium / (R) Rear Fender, Molding - Scratch & Dent - Small / Trunk Hood, Rear Gate - Scratch & Dent - Minimal / Rear Bumper, Lamps, Panels - Scratch - Small / (L) Rear Fender, Molding - Dent - Minimal / (L) Rear Door, Molding - Scratch & Dent - Small / (L) Mirror - Scratch - Small / (L) Front Door, Molding - Scratch & Dent - Minimal / (L) Front Fender, Molding - Repair mark - Yes / (R) Front Fender, Molding - Scratch & Dent - Small / Front Bumper, Grille, Lamps - Repair mark - Yes / Front Bumper, Grille, Lamps - Scratch - Small
