General Information

Make	Toyota	Model	Vios
YOM	2009	Odo Meter Reading	125,175
Registration No.	NPO658	Chassis No.	NCP929016571
CC	1.3	Transmission	M/T
Fuel Type	Gas	Type of Body	Sedan
Colour	Red

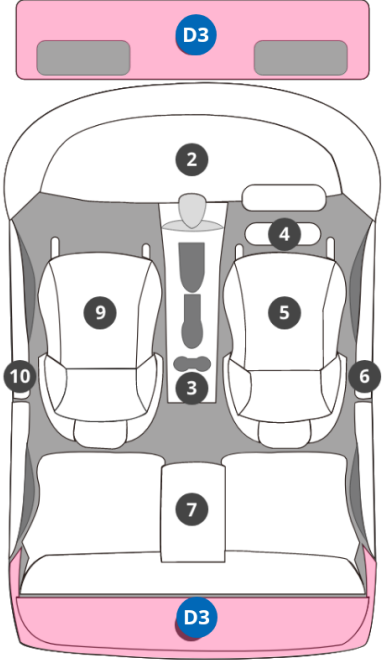
Interior Evaluation : B	Exterior Evaluation : D

<p>a : Cut, Fray d : Loose, Deformed k : Animal Hair s : Smell t : Cigarette Burns x : Defective y : Stain</p>

<p>A : Scratch AU : Scratch & Dent B : Modified C : Corrosion G : Stone chip P : Faded S : Rust SC : Rust & Corrosion U : Dent X : Defective Y : Crack, Gap</p>
Remarks Ceiling - Loose, Deformed - Medium / Trunk Room - Loose, Deformed - Medium	Remarks Bonnet - Repair Traces - Yes / (R) Rear Fender - Repair Traces - Yes / (R) Rear Door - Repair Traces - Yes / Roof - Repair Traces - Yes / (R) Front Fender, Molding - Scratch - Small / (R) Mirror - Faded(Color, Gloss) - Yes / (R) Front Door, Molding - Scratch & Dent - Minimal / (R) Rear Door, Molding - Repair mark - Difference in Color / (R) Rear Fender, Molding - Repair mark - Difference in Color / (R) Rear Door, Molding - Scratch - Minimal / (R) Rear Fender, Molding - Scratch & Dent - Minimal / Rear Bumper, Lamps, Panels - Crack, Gap - Small / (L) Rear Fender, Molding - Scratch - Small / (L) Rear Door, Molding - Scratch & Dent - Medium / (L) Step, In-panel, Side Spoiler - Scratch - Small / (L) Front Door, Molding - Scratch & Dent - Small / (L) Mirror - Crack - Cracks / (L) Front Fender, Molding - Scratch - Minimal / Front Bumper, Grille, Lamps - Scratch - Medium / Trunk Hood, Rear Gate - Scratch - Minimal / Bonnet, Headlight - Scratch - Minimal

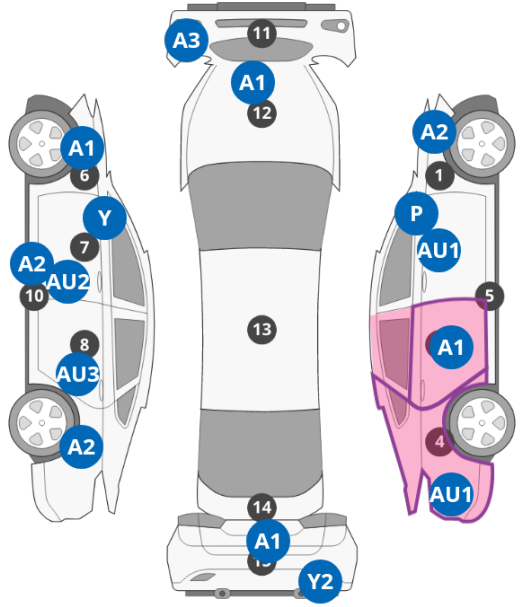
Inspector Notes
With Lto plate, with spare tire and jack, 1key, no warranty booklet, no tools, scratches on headlights and taillights, faded bumper ,cover under bonet missing, trunk room cover missing,
