General Information

Make	Toyota	Model	Hilux Tamaraw
YOM	2025	Odo Meter Reading	12,752
Registration No.	NKQ5314	Chassis No.	PAHACACA7S6425047
CC	2.4	Transmission	M/T
Fuel Type	Diesel	Type of Body	Utility Vehicle
Colour	White

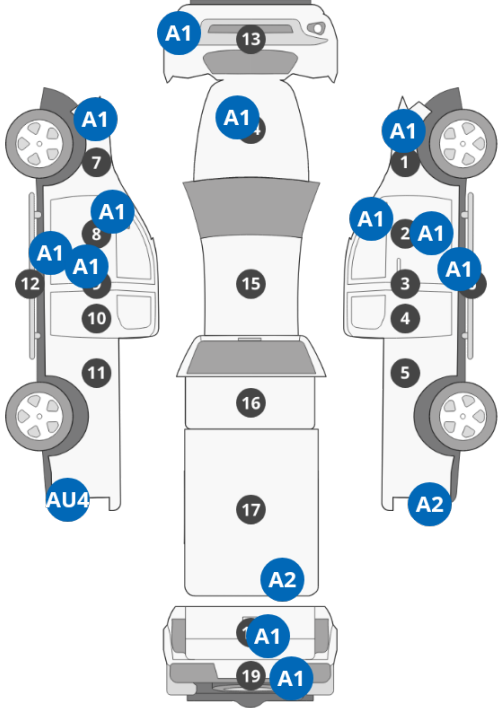
<p>A : Scratch AU : Scratch & Dent B : Modified C : Corrosion G : Stone chip P : Faded S : Rust SC : Rust & Corrosion U : Dent X : Defective Y : Crack, Gap</p>
<p>Remarks Defects not found</p>	<p>Remarks (R) Front Fender, Molding - Scratch - Minimal / (R) Mirror - Scratch - Minimal / (R) Front Door, Molding - Scratch - Minimal / (R) Step, In-panel, Side Spoiler - Scratch - Minimal / (R) Side Gate - Scratch - Small / Rear Gate - Scratch - Minimal / Rear Bumper, Lamps, Panels - Scratch - Minimal / (L) Side Gate - Scratch & Dent - Large / (L) Step, In-panel, Side Spoiler - Scratch - Minimal / Roof - Scratch - Small / (L) Mirror - Scratch - Minimal / (L) Front Door, Molding - Scratch - Minimal / (L) Front Fender, Molding - Scratch - Minimal / Front Bumper, Grille, Lamps - Scratch - Minimal / Bonnet, Headlight - Scratch - Minimal</p>

<p>Inspector Notes</p>
<p>With Lto plate, with warranty booklet, with jack and spare tire, 2keys, no tools, scratches on headlights and taillights</p>
