General Information

Make	Toyota	Model	Vios
YOM	2025	Odo Meter Reading	8,266
Registration No.	CCQ3236	Chassis No.	PA1B18F35S4292394
CC	1.3	Transmission	CVT
Fuel Type	Gas	Type of Body	Sedan
Colour	Blackish Red Mica

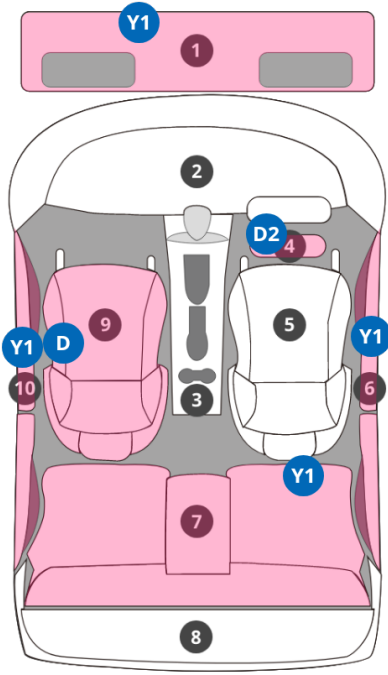
Interior Evaluation : B	Exterior Evaluation : C

<p>a : Cut, Fray d : Loose, Deformed k : Animal Hair s : Smell t : Cigarette Burns x : Defective y : Stain</p>

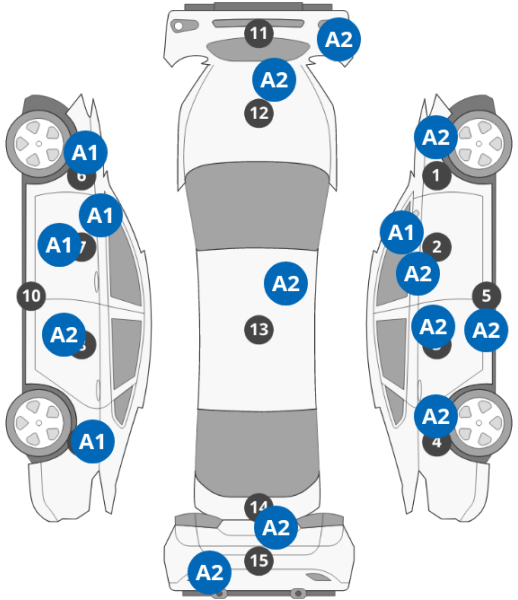
<p>A : Scratch AU : Scratch & Dent B : Modified C : Corrosion G : Stone chip P : Faded S : Rust SC : Rust & Corrosion U : Dent X : Defective Y : Crack, Gap</p>
<p>Remarks (R) Front Trim - Grime - Minimal / (L) Front Trim - Grime - Minimal / (L) Front Floor Mat - Worked - Small / Ceiling - Grime - Minimal / (L) Front Seat - Worn - Yes / Rear Seat - Grime - Minimal</p>	<p>Remarks (R) Front Fender, Molding - Scratch - Small / (R) Mirror - Scratch - Minimal / (R) Step, In-panel, Side Spoiler - Scratch - Small / (R) Front Door, Molding - Scratch - Small / (R) Rear Door, Molding - Scratch - Small / (R) Rear Fender, Molding - Scratch - Small / Rear Bumper, Lamps, Panels - Scratch - Small / Trunk Hood, Rear Gate - Scratch - Small / (L) Rear Fender, Molding - Scratch - Minimal / (L) Rear Door, Molding - Scratch - Small / (L) Front Door, Molding - Scratch - Minimal / (L) Mirror - Scratch - Minimal / (L) Front Fender, Molding - Scratch - Minimal / Front Bumper, Grille, Lamps - Scratch - Small / Bonnet, Headlight - Scratch - Small / Roof - Scratch - Small</p>
